MICHELE
SCHULER

13809 212TH DR NE, WOODINVILLE

**13809 212TH DR NE,
WOODINVILLE**

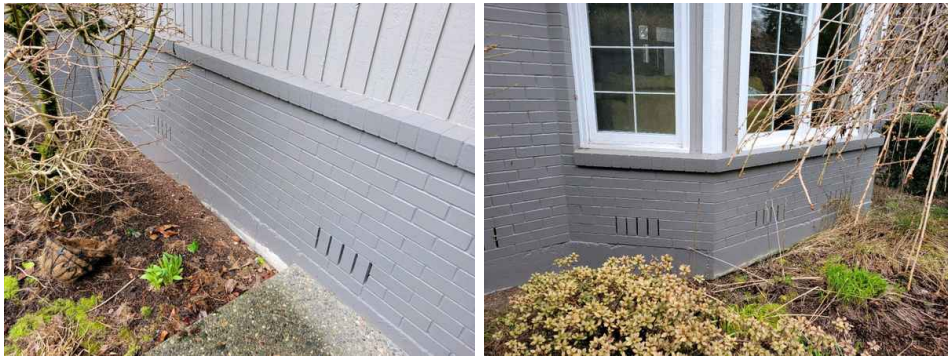
BRICK VENEER - WEEP HOLES BLOCKED/MISSING

The weep holes of the brick veneer siding appeared to be blocked or missing. Weep holes are designed to facilitate proper drainage and air flow for the siding. I recommend having a qualified contractor evaluate and make the appropriate corrections.

Contact a qualified masonry professional.

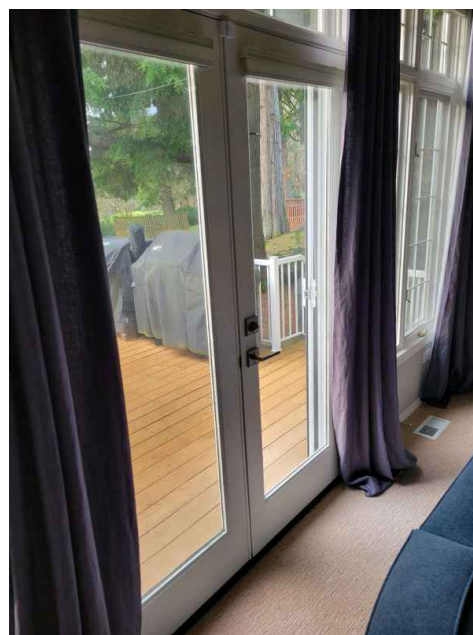
The deadbolt lock appeared to be difficult to lock at the time of inspection. I recommend repair or replacement for increased safety.

Contact a handyman or DIY project

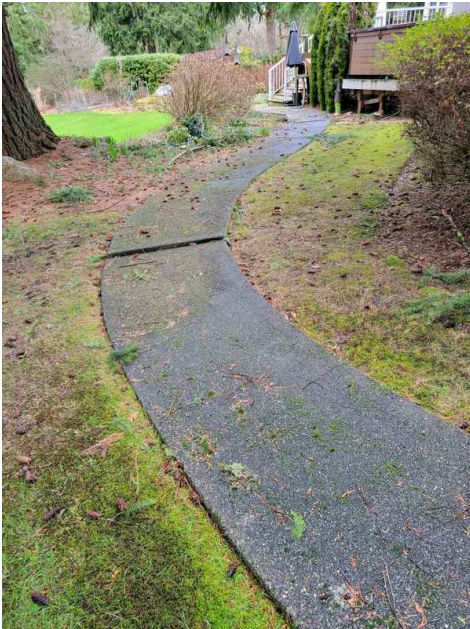
WALKWAY TRIP HAZARD

Walkway appeared to be uneven and could pose a trip hazard. I recommend repair by a qualified contractor for increased safety.

Contact a qualified concrete contractor.

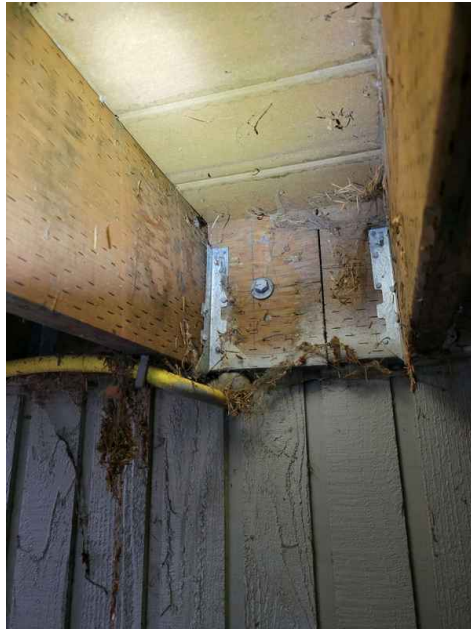
The ledger board appeared to be installed over the siding. This is a safety concern as the strength of the attachment is reduced. For increased safety, I recommend a decking contractor to evaluate and repair or replace.

Contact a qualified deck contractor.

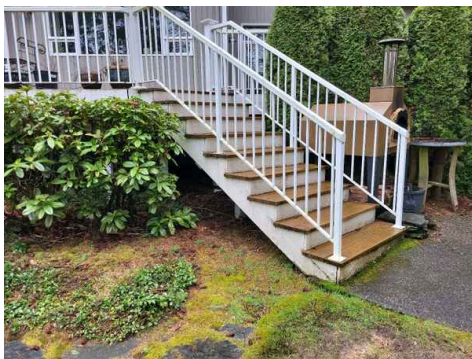
STAIRS - DETERIORATED

One or more sections of the exterior stairs were deteriorated. For increased safety, I recommend that a qualified contractor evaluate for repair.

Contact a qualified deck contractor.

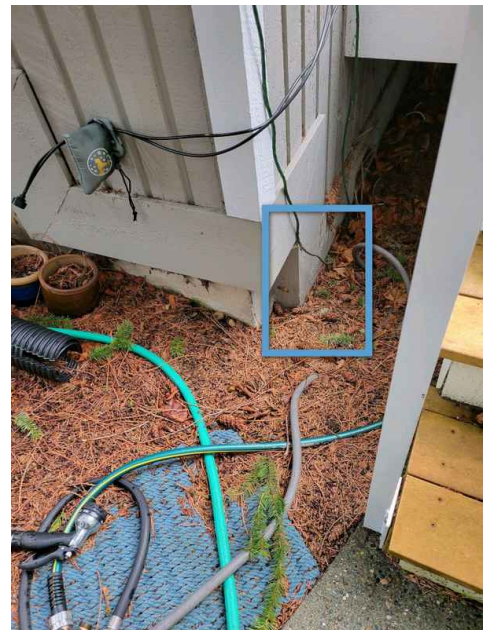
There appeared to be soil in contact with wood. This is a conducive condition for wood deterioration and wood destroying organisms. Recommend keeping all soil well clear of wood components.

Contact a qualified landscaping contractor

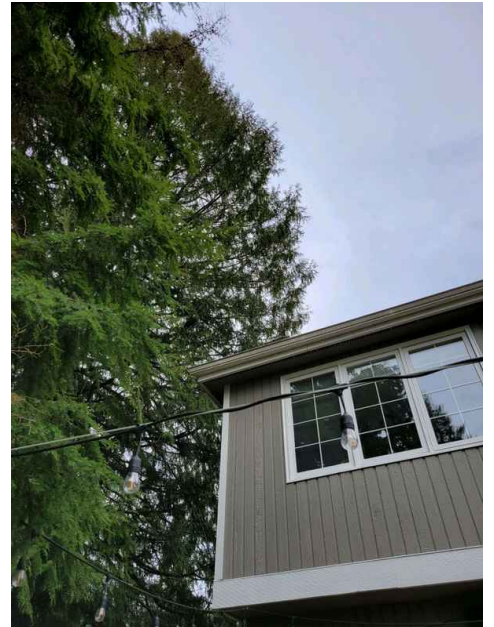
Trees observed overhanging the roof. This can create shady areas on the roof which can lead to moss growth and cause accelerated deterioration of the roof materials. It can also allow rodents to access the roof and attic. Recommend a qualified tree service trim the overhang.

Contact a qualified tree service company.

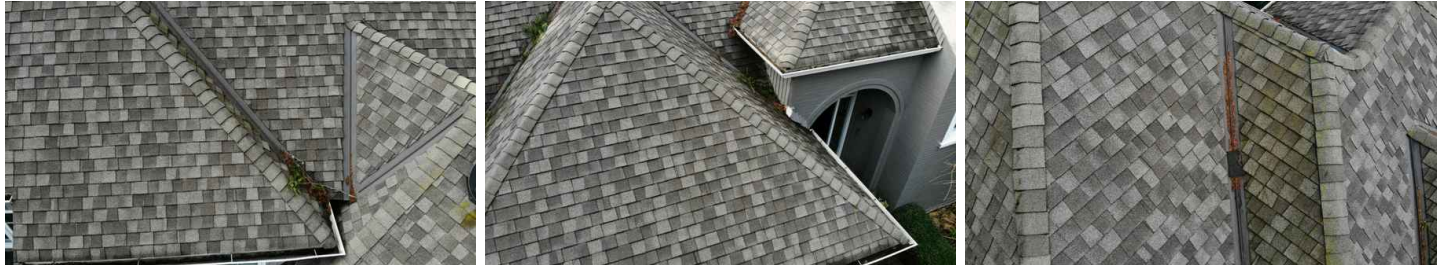
Debris is accumulating on the roof in one or more locations. All debris should be removed to ensure proper drainage. These areas should be kept clear to reduce the potential for backups and possible water penetration into the structure. Note, pressure washing is never recommend. I also recommend that a qualified roofing contractor evaluate the entire roofing system after the debris has been removed for repairs/replacement.

Contact a qualified roofing professional.

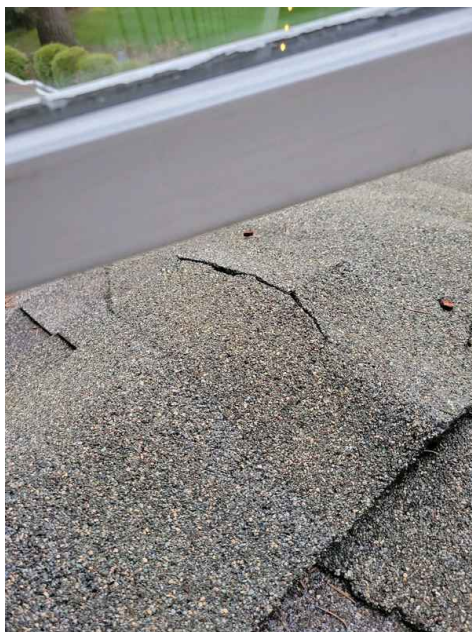
SHINGLE - DAMAGE

There appeared to be damaged shingles. I recommend a qualified roofer to evaluate the entire roof for repair/replace to prevent any potential leaks.

Contact a qualified roofing professional.

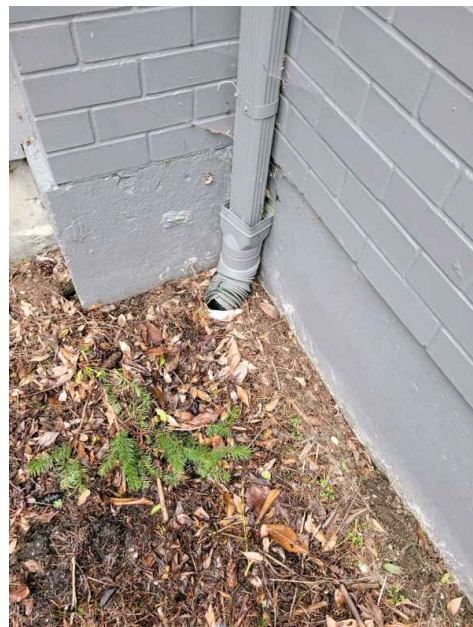
DOWNSPOUT MISSING POSITIVE CONNECTION

The downspout did not appear to have a positive connection with the in-ground drainage system. I recommend repair as necessary to divert water away from the structure.

Contact a qualified gutter contractor

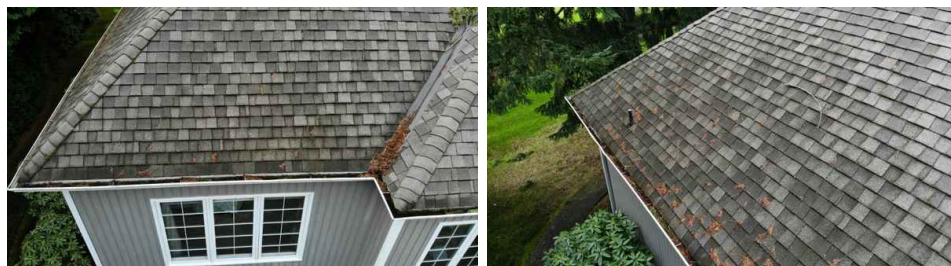
Excessive debris noted in gutters at time of inspection. It is common maintenance of a house to have the gutters cleaned once or twice a year. Recommend cleaning to facilitate water flow.

Contact a handyman or DIY project

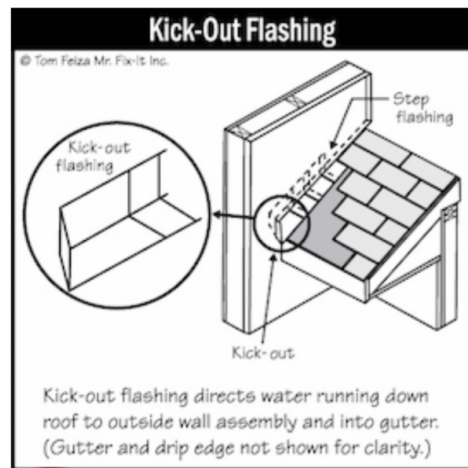
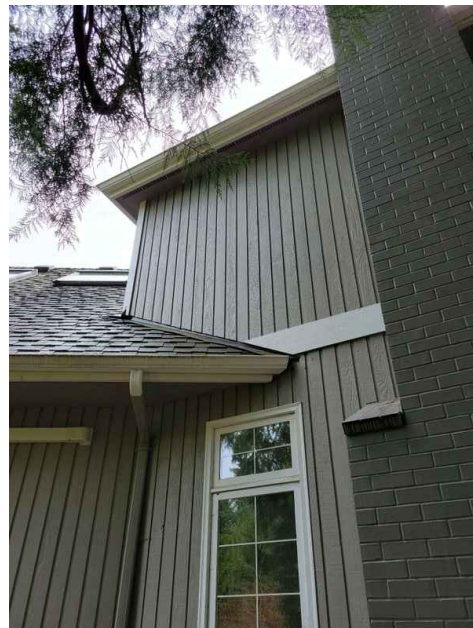
KICK OUT FLASHING MISSING

Missing kick out flashing at sidewall to gutter intersection. This can lead to an excessive amount of rain runoff to be localized at the area of the siding next to the gutter which can lead to water intrusion and potential structural damage. Kick out flashing is a piece of metal that directs water out and away from the siding and into the gutter and is a minor repair can save the homeowner from expensive/extensive future repairs. I recommend that a qualified roofing contractor repair/replace as necessary.

Recommendation
Contact a qualified roofing professional.

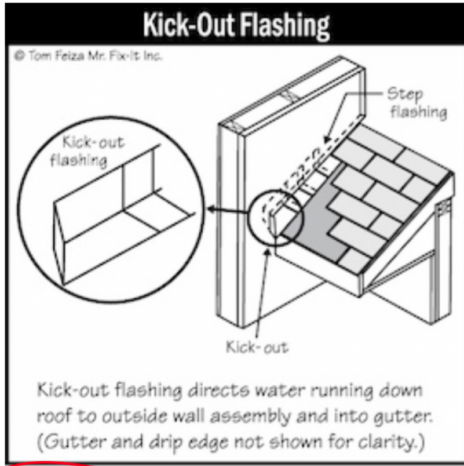
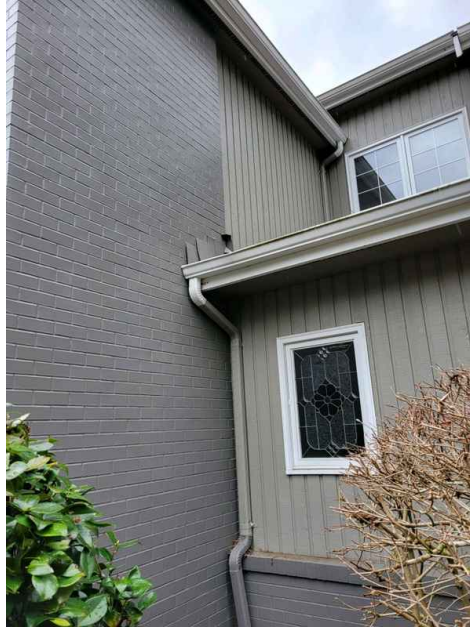
The flashing designed to divert water away from the sidewall and into the gutter, known as kick out flashing, appeared to be minimal. This creates an area reliant on sealant. I recommend that a qualified roofing contractor evaluate and repair as necessary to deter moisture intrusion.

Contact a qualified roofing professional.

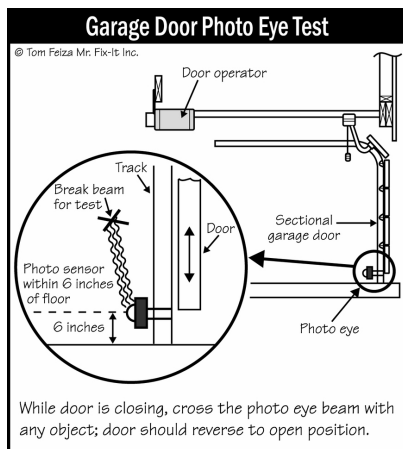
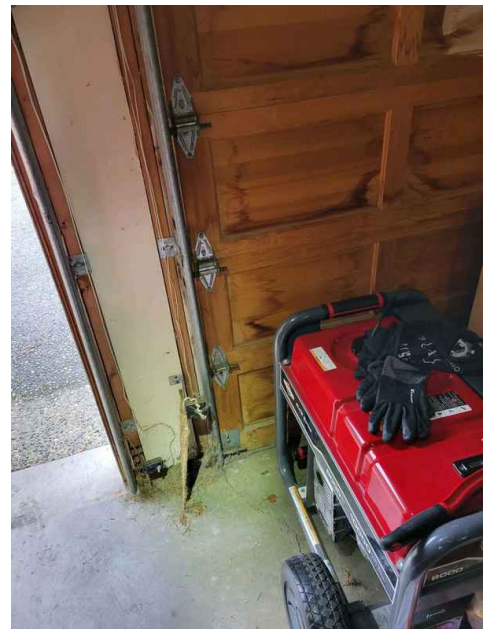
ELECTRONIC SAFETY EYES INSTALLED HIGH

The garage door electronic safety eyes appeared to be installed too high. Generally, the safety eyes are installed within 4-8" of the floor. I recommend installing per manufacturer specifications.

Contact a qualified garage door contractor.

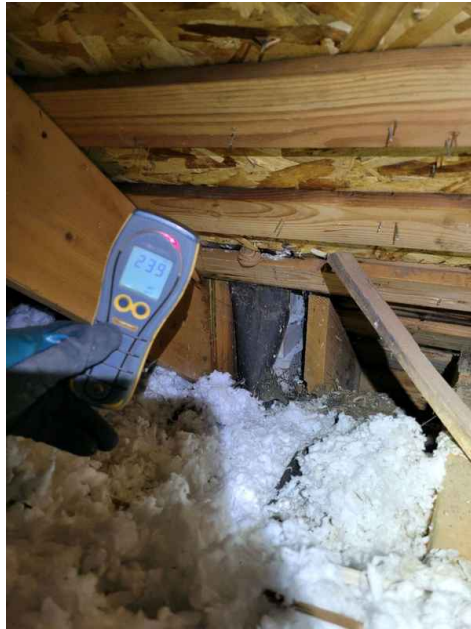
MOISTURE STAINS IN ATTIC ELEVATED MOISTURE
