KEY INSPECTION SERVICES, LLC
#1 Home Education and Inspection Company

INSPECTION REPORT COPY

4452 Ferncroft Rd
Mercer Island, WA 98040

03/15/2024

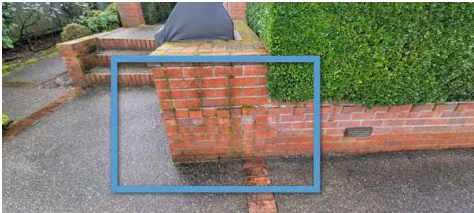
Rear Patio At Grill

BRICK VENEER - STEP CRACKS

There appeared to be one or more areas of step cracking and cracked bricks on the veneer siding. This may indicate foundation settling and/or issues with the steel lintels over window openings. I recommend a qualified siding contractor to evaluate further for repairs/replacement.

Recommendation
Contact a qualified siding specialist.

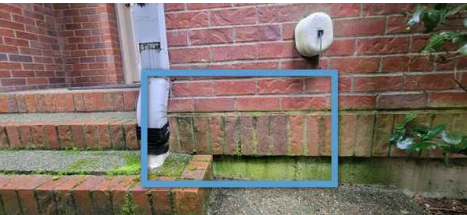
Right Side, Service Door Adjacent

BRICK VENEER - WEEP HOLES BLOCKED/MISSING

The weep holes of the brick veneer siding appeared to be blocked or missing. Weep holes are designed to facilitate proper drainage and air flow for the siding. I recommend having a qualified contractor evaluate and make the appropriate corrections.

Recommendation
Contact a qualified masonry professional.

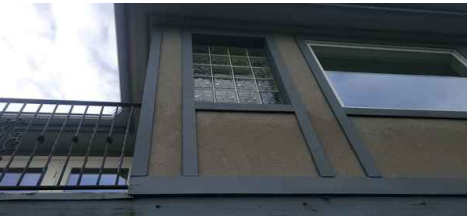
2nd Floor Various Locations

EIFS, also known as Faux Stucco or Exterior Insulated Finished System, was installed on the home. EIFS is a specialized siding system requiring near perfect installation and ongoing maintenance. Any moisture that gets behind the visible surface can severely damage the wall sheathing and structure. Determining if there is moisture intrusion or non-visible rot/damage is beyond the scope of a standard home inspection. We recommend a qualified EIFS siding inspector evaluate the siding system for moisture intrusion and potential damage.

Contact a qualified siding specialist.

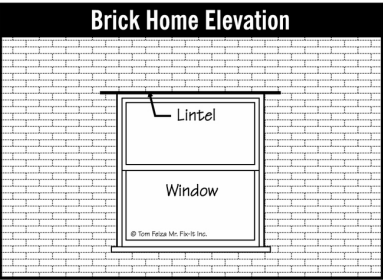
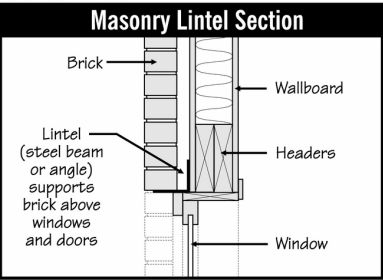
LINTEL RUSTING/DETERIORATING

Rust and deterioration was noted at the Lintels. This can develop into structural concerns of the veneer. I recommend a qualified siding contractor familiar with this type of siding to repair/replace.

Contact a qualified professional.

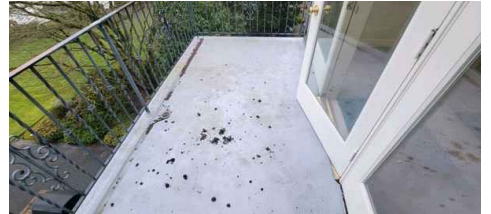
Rear Balcony

Inquire with seller regarding the history and operation of sealed decking system. The system is not accessible from the area below. Sealed decking systems need continual sealant and moisture control to prevent wood deterioration of underlying structure.

Contact a qualified deck contractor.

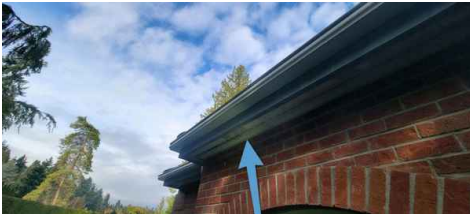
Front, Garage Adjacent

SOFFIT - STAINING, NO MOISTURE

Staining was observed at the soffit area. This may indicate a current or past roof leak and/or a flashing defect. No elevated moisture at the time of inspection. Recommend evaluation by a qualified roofing contractor for repair/replacement.

Contact a qualified roofing professional.

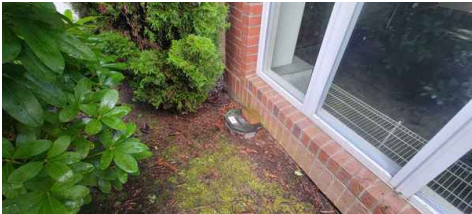
Various Locations

RODENT BAIT BOX NOTED

Contact a qualified pest control specialist.

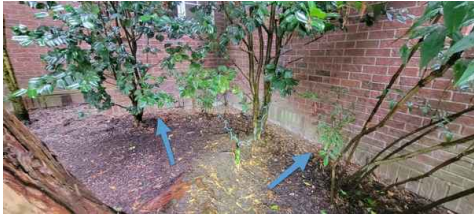
Front

There appeared to be soil in contact with the siding. This is a conducive condition for wood deterioration and wood destroying organisms. Recommend maintaining a 6 to 8 inch clearance between soil and siding.

Contact a qualified landscaping contractor

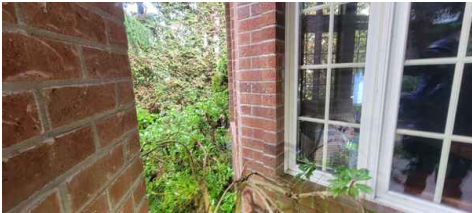
Various Locations

We recommend maintaining a 12" clearance between vegetation and the structure, and a minimum 4" clearance between soil and wood products to avoid conducive conditions for rodent entry and/or wood destroying organisms as well as wood rot. Areas covered by vegetation were not visible for inspection. Not all pictures represent all vegetation in contact with the structure.

Contact a qualified landscaping contractor

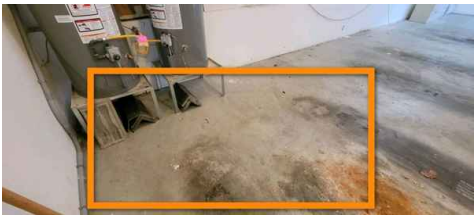
Garage

For increased safety I recommend adding a bollard post in front of the furnace/water heater in the garage. This can help prevent a vehicle from impacting the appliances. Inquire with a qualified contractor for this safety upgrade.

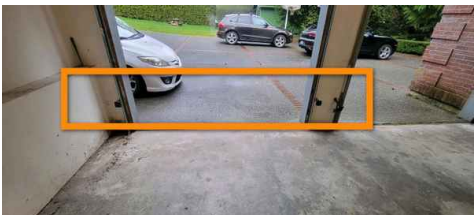
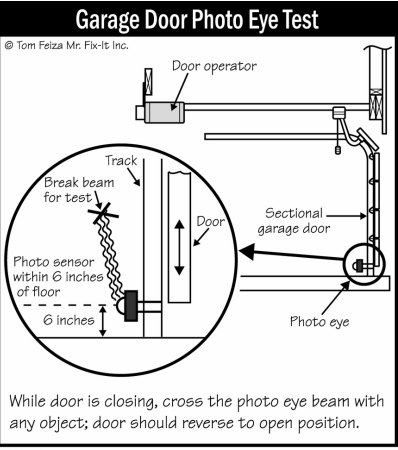
Door 4

The garage door electronic safety eyes appeared to be installed too high. Generally, the safety eyes are installed within 4-8" of the floor. I recommend installing per manufacturer specifications.

Recommendation
Contact a qualified garage door contractor.

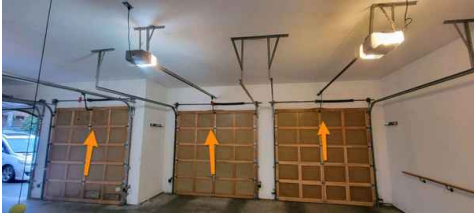
All Garage Doors

MISSING CROSS BRACING
GARAGE

There appeared to be missing cross bracing on the garage door opener and/or the track. This is designed to keep components from improper movement. Recommend that a qualified garage door contractor evaluate for repair or replacement.

Recommendation
Contact a qualified garage door contractor.

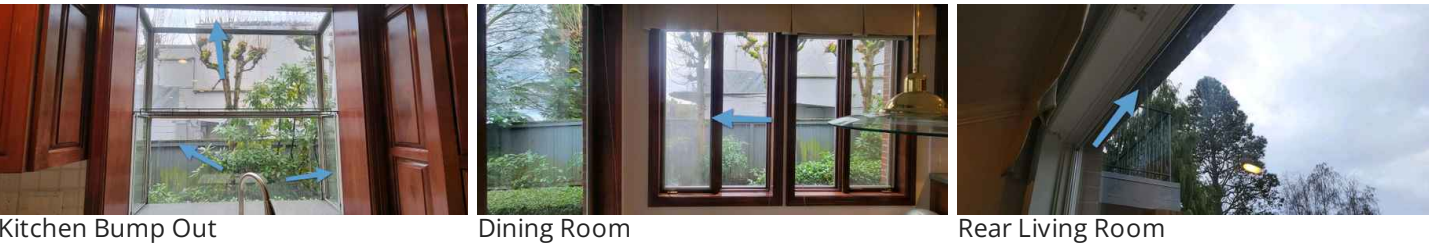
Window showed symptoms of a breached seal, or failure of the seal between the two pieces of glass. The symptoms often take the form of condensation between the panes of an insulated glass unit. These failures are more a cosmetic consideration than a functional one, as the breach does not appreciably affect the thermal insulation value of the window unit. However, the fog cannot be removed by cleaning the exposed surfaces of the unit. There is no simple fix for this condition, short of replacing the entire glazing unit. Also, condensation is not always visible. If the failure is recent, a failed window may not be obvious, since condensation doesn't usually form until the window is heated by direct sunlight. Windows in the shade may show no evidence of failure, so it is nearly impossible to observe and report all failed double-paned windows. Not all windows may be represented in the photos. I recommend a qualified window contractor to evaluate all windows for repair/replacement.

Recommendation
Contact a qualified window repair/installation contractor.

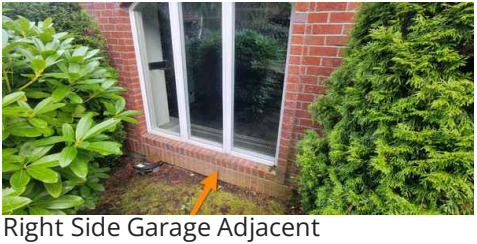
I was unable to verify whether or not the windows were made of tempered glass at the time of inspection. Windows near stairs or ground level should be safety glass. I recommend a qualified window specialist to evaluate and repair/replace as necessary.

Recommendation
Contact a qualified window repair/installation contractor.

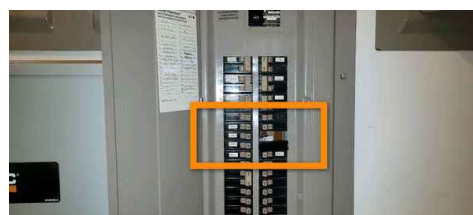
Main Panel

OPENING IN PANEL COVER

There were one or more openings in the electrical panel cover which is a safety hazard. Often a simple repair. Fillers can be purchased from most hardware stores. Recommend repair for increased safety.

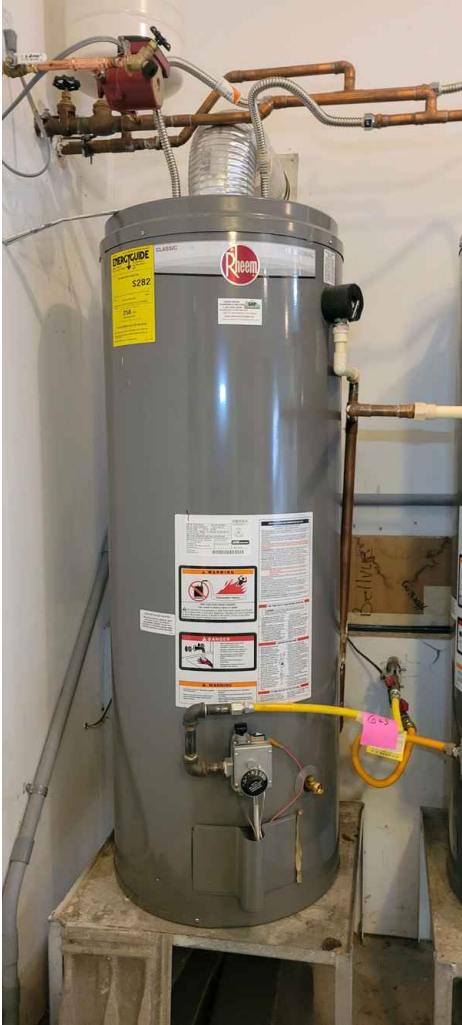
Left Hot Water Systems, Controls, Flues & Vents: Capacity 50 Gallons	Left Hot Water Systems, Controls, Flues & Vents: Power Source/Type Gas
Left Hot Water Systems, Controls, Flues & Vents: Approximate Age Of Water Heater 10 Years Old

Left Hot Water Systems,
Controls, Flues & Vents: Seismic
Straps
No

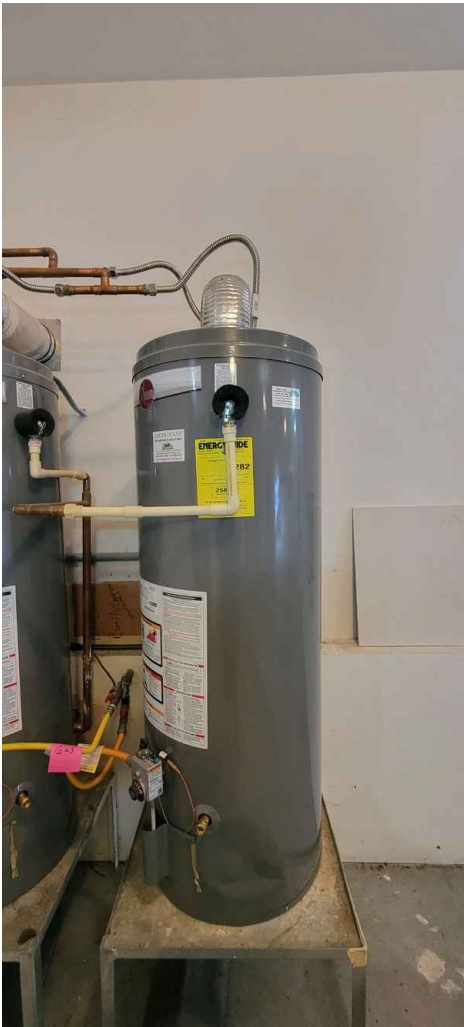
Right Side Hot Water Systems,
Controls, Flues & Vents 2:
Approximate Age Of Water
Heater
10 Years Old

Right Side Hot Water Systems,
Controls, Flues & Vents 2:
Capacity
50 Gallons

Right Side Hot Water Systems,
Controls, Flues & Vents 2: Power
Source/Type
Gas

Right Side Hot Water Systems,
Controls, Flues & Vents 2: Seismic
Straps
No

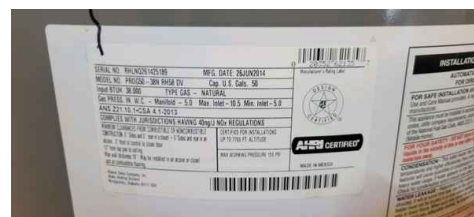
10 Years Old

The water heater is nearing or past the end of its design life, the age is notated in the information section. Standard life is 8-12 years. I recommend budgeting for replacement. If one is not already installed, I recommend installation of a water alarm in a drain pan at the base of the water heater to alert you to a leak. I also recommend maintenance to the water heater to prevent any possible damage.

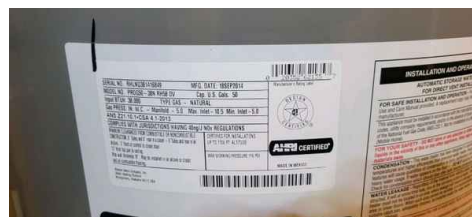
10 Years Old

The water heater is nearing or past the end of its design life, the age is notated in the information section. Standard life is 8-12 years. I recommend budgeting for replacement. If one is not already installed, I recommend installation of a water alarm in a drain pan at the base of the water heater to alert you to a leak. I also recommend maintenance to the water heater to prevent any possible damage.

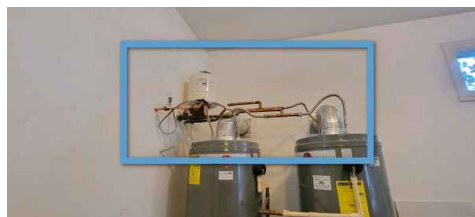
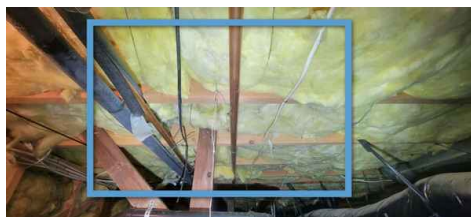
Garage

Missing insulation on plumbing pipes in one or more areas. Recommend insulating plumbing lines in crawlspace-garage-exterior to help deter freeze potential. Generally, a simple repair, but can be expensive if pipes burst.

Recommendation

Contact a qualified handyman.

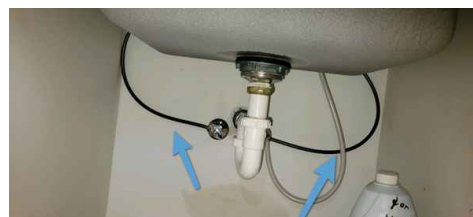
Laundry Room

Some or all of the plumbing supply pipes found in the home appeared to be made of polybutylene which was common in the 80's through early 90's and was recalled under a class action lawsuit in 1995. This type of supply pipe has been known to fail at the fittings. We recommend upgrading to higher quality plumbing with a qualified plumber.

Recommendation

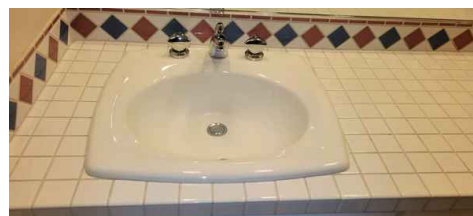
Bathroom off Game Room

One or more of the pop-up assemblies did not appear to function properly during functional testing. This is a typical home owner fix. If further assistance is needed I recommend a qualified plumber to evaluate for repair/replacement.

Recommendation

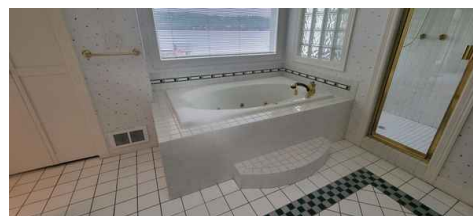
Primary Bathroom

The motor for the jetted tub did not appear to be accessible at the time inspection. Typically, there is an access panel to allow for inspection and maintenance of the motor and electrical connections. I recommend that a qualified contractor make the area accessible and that a qualified contractor evaluate the motor and electrical connections. Due to this not being accessible the jetted tub was not tested.

Recommendation

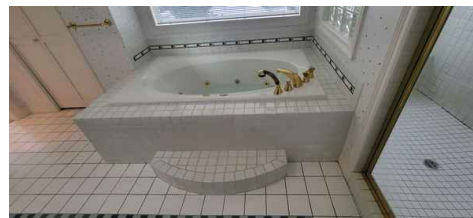
Primary Bathroom

The jetted tub did not appear to be operational at time of inspection. I recommend inquiring with sellers for history and having a qualified plumbing contractor evaluate for repair/replacement.

Recommendation

Contact a qualified plumbing contractor.

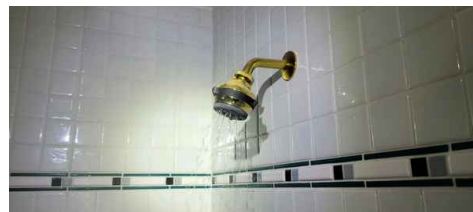
Primary Bathroom Shower

Poor water flow was noted when more than one fixture was operated at the same time. I recommend a qualified plumber to evaluate further to increase the water flow.

Recommendation

Contact a qualified plumbing contractor.

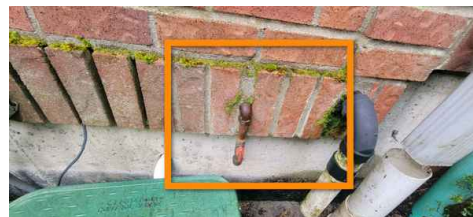
Rear

CORROSION

Corrosion, rust noted on gas pipes in one or more locations. Excessive corrosion can lead to pitting and potential leaks. Recommend evaluation and any necessary replacement by qualified plumbing contractor.

Recommendation

Contact a qualified plumbing contractor.

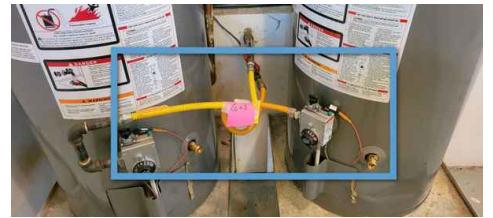
Garage

MISSING SEDIMENT TRAP

Missing sediment trap in gas line. A sediment trap is installed to catch any debris which can pose a problem in the orifices of the gas burning appliances. Recommend evaluation and repair by a qualified plumbing contractor.

Recommendation

Contact a qualified plumbing contractor.

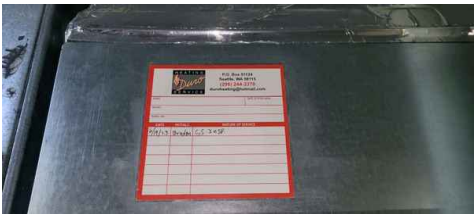
6/19/2023

Service sticker on the furnace indicated recent servicing. I recommend obtaining a copy of the receipt for your records, as well as having a point of contact for a future maintenance and operation questions. The standard life expectancy is 15 to 18 years with proper maintenance.

Recommendation
Contact a qualified HVAC professional.

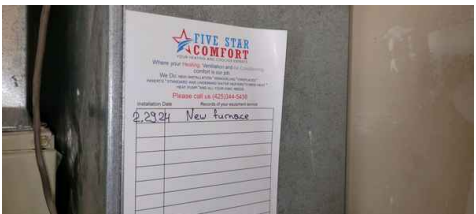
10.2.1 Equipment 2, 2nd Floor
FURNACE - NEW UNIT

The furnace appears to be a newer installation. I recommend inquiring with a seller about any permits, contractor information, and warranty information for your records.

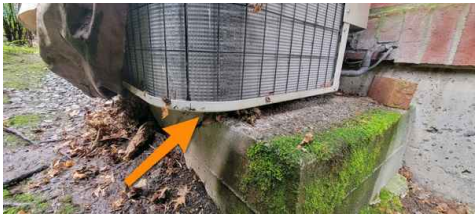
The A/C compressor unit did not appear to be secured to the pad at the time of inspection. I recommend a qualified HVAC specialist to evaluate and repair/replace as necessary.

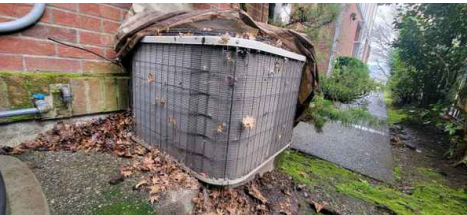
Current Exterior AC Unit Not Connected to New Furnace

A/C INOPERABLE

The A/C did not appear to operate using normal home owner controls at the time of inspection. I recommend inquiring with the sellers regarding operability and evaluation for repairs or replacement as needed by a qualified professional. Additionally I recommend reviewing for operability during walk through.

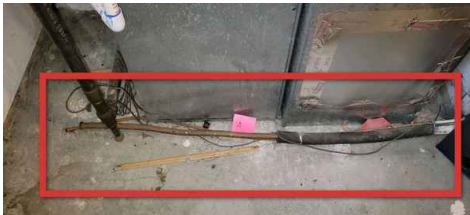
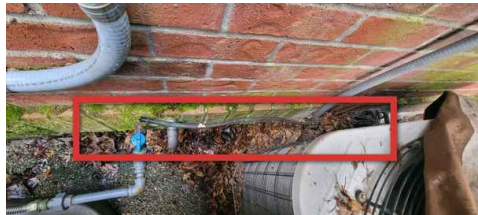
Current Exterior AC Unit Not Connected to New Furnace

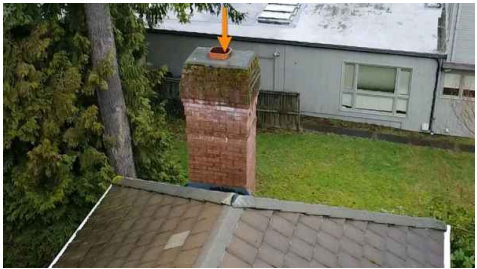
Left Side

MISSING SPARK ARRESTOR/RAIN CAP

The chimney appeared to be missing a spark arrestor/rain cap. This could allow pest entry into the chimney, allow water to enter the chimney and freeze, potentially damaging the firebox/damper/chimney/etc., as well as allowing fire embers to exit the home, potentially leading to fire hazards. Recommend a qualified chimney sweep evaluate for cleaning and repairs.

Recommendation
Contact a qualified chimney contractor.

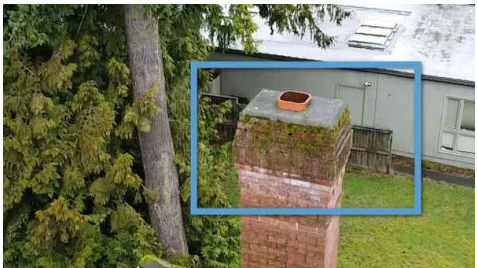
Left Side

Moss growth observed on the chimney. Moss retains moisture and can speed deterioration of brick and mortar joint material. I recommend cleaning all moss from chimney and repair as needed.

Recommendation
Contact a qualified professional.

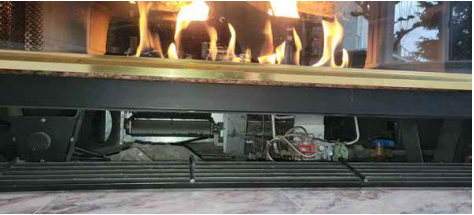
Living Room

Inquire with seller on history of servicing of the gas fireplace. We recommend regular service as per manufacturers specifications. Unable to determine when most recent service was performed.

Recommendation
Contact the seller for more info

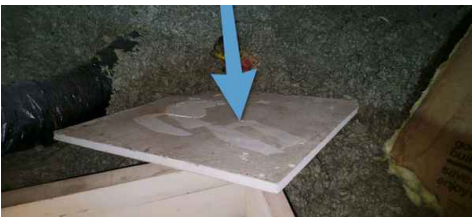
Front, Main Attic

ATTIC HATCH MISSING INSULATION

Missing insulation on the attic hatch was noted. This can effect the heating and cooling. I recommend adding proper insulation to the attic hatch.

Recommendation
Contact a qualified insulation contractor.

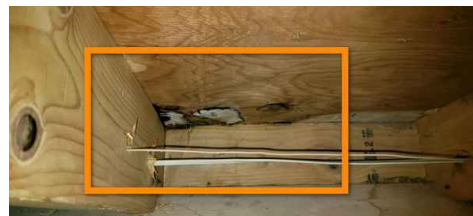
Safety Concern/Recommend Repair**FUNGAL STAINING -
ATTIC**

Residue observed on attic sheathing appeared to be fungal in nature. Ventilation of attic area may need alteration or correction. I recommend a qualified fungal growth specialist to review for potential remedy. Poor ventilation can decrease the life of the roof. I did not inspect, test or determine if this growth is or is not a health hazard. If you would like further technical advice we recommend contacting our office to schedule a mold sampling test. This type of testing is beyond the scope of a standard home inspection. The underlying cause is moisture or dampness.

Partial Attic at Front Game Room,
Elevated moisture reading

Recommendation

Contact a qualified environmental contractor

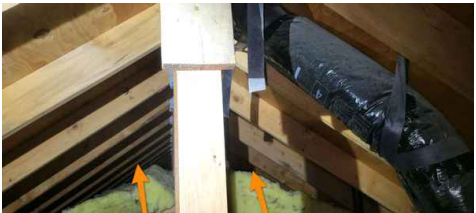
Front, Main Attic

LOW CLEARANCE

Due to minimal clearance areas of the attic were minimally inspected from a distance.

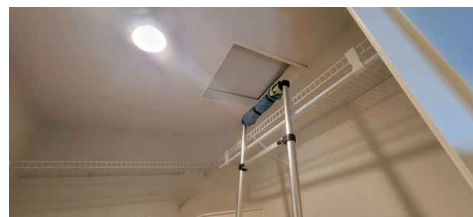
Permanent Closet Installation

The attic was minimally accessible and only inspected from the entrance due to one of the following reasons: inadequate clearance or path of travel for safe inspection, blown insulation, asbestos insulation or sprinkler system installation.

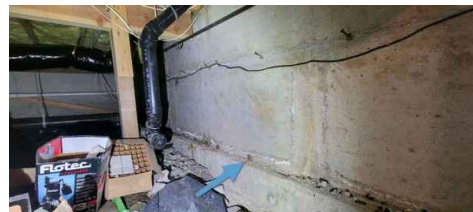
Right of Entry, Front Wall

White efflorescence (powder substance) and staining on concrete foundation walls indicates moisture is in contact with the masonry. This does not necessarily indicate that intrusion will occur. I recommend checking the gutters and the downspout drain lines for proper operation. Efflorescence is found on many homes without water intrusion occurring inside the home. But, it should alert you to the possibility that future steps may be needed.

Contact a qualified professional.

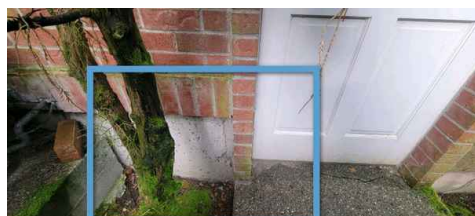
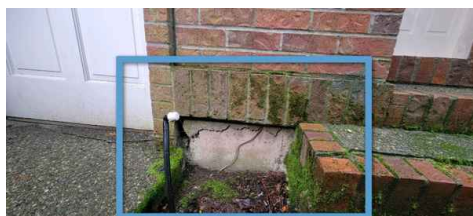
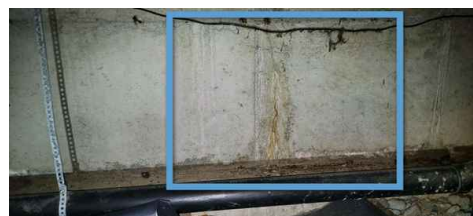
FOUNDATION CRACKS - MINOR

Minor cracking was noted at the foundation. This is common as concrete ages and shrinkage surface cracks are normal. Recommend sealing the crack to prevent any further damages by a qualified concrete contractor.

Contact a qualified professional.

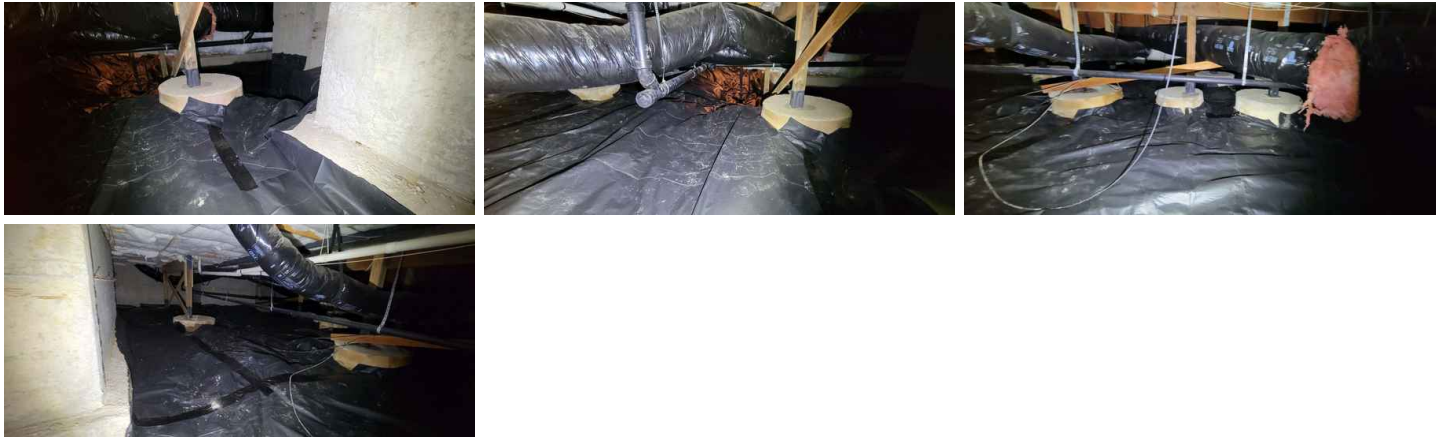
14.3.1 Columns and piers

WOOD TO CONCRETE CONTACT

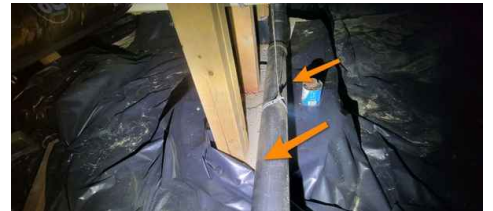
Center Posts

One or more posts appeared to be in contact with concrete. Typically there is a moisture barrier between the two components. I recommend a qualified contractor to evaluate for potential repair or replacement.

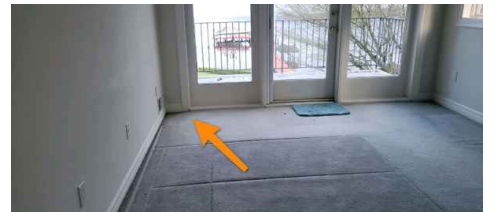
2nd Floor Rear Right Side Bedroom

There appeared to be a slope in the floor. Unknown to the inspector whether or not this was an active issue. I recommend a qualified foundation contractor to evaluate and repair/replace as necessary.

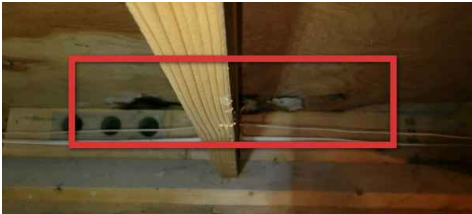
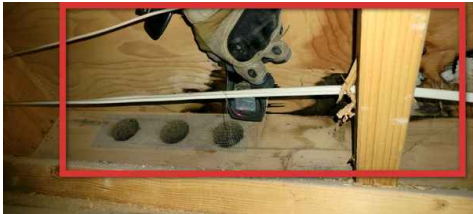
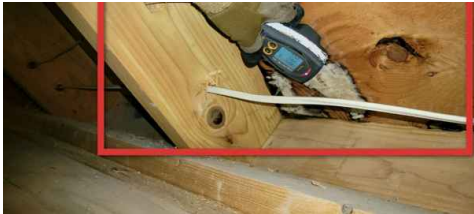
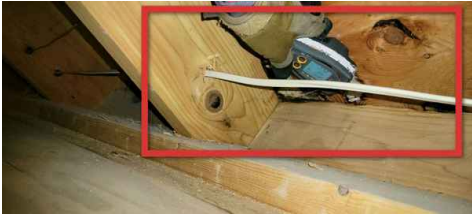
Partial Attic at Front Game Room,
Elevated moisture reading

14.5.1 Roof Structure and Attic

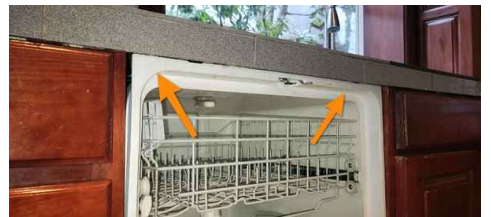
BARBECUES NOT INSPECTED

Barbecues are outside the scope of a standard home inspection. I recommend inquiring with the seller on any history of maintenance to the barbecue.

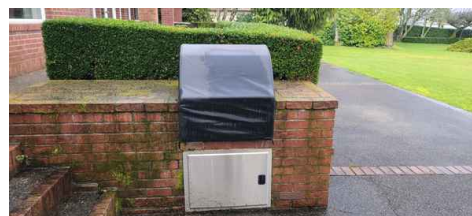
Items Not Inspected

BUILT IN SPEAKER SYSTEM

Recommend inquiring with seller for functionality of built-in speaker system.

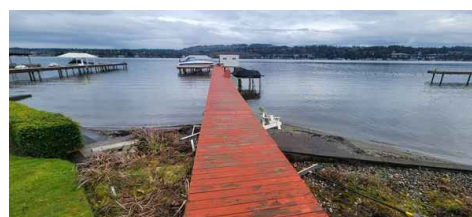
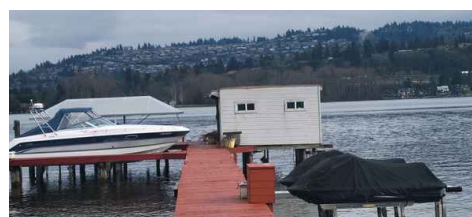
Boat House

EXTRA BUILDINGS

I did not inspect any additional buildings. I only inspected the main structure. Deficiencies may exist with these structures or buildings. Our company makes no representation to the condition of these structures or buildings. I recommend inquiring with the seller about any history, maintenance and information on the additional buildings.

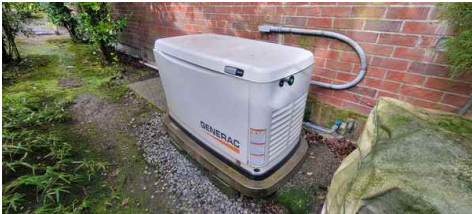
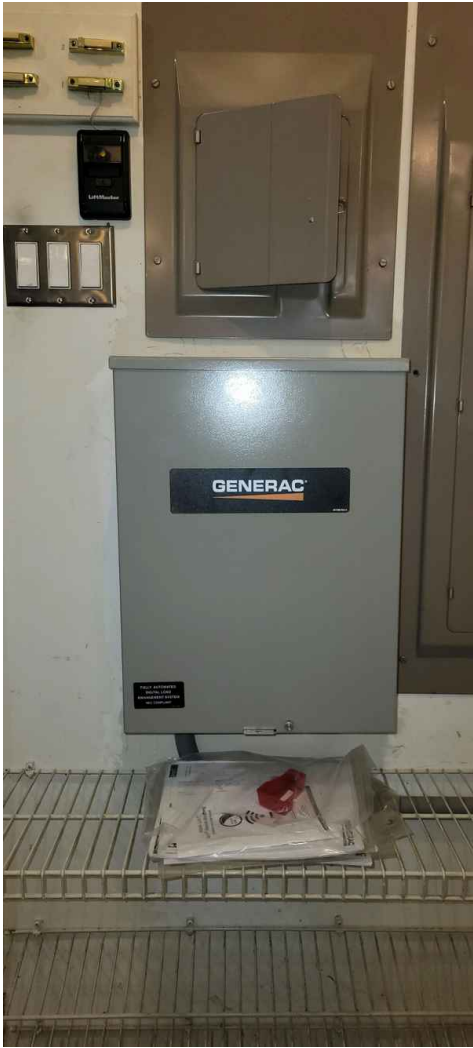
Items Not Inspected

GENERATOR

Backup generator systems are outside the scope of a standard home inspection. Generator system not inspected. Inquire with seller regarding function and maintenance of this system. For further technical information I recommend inquiring with a qualified electrician.

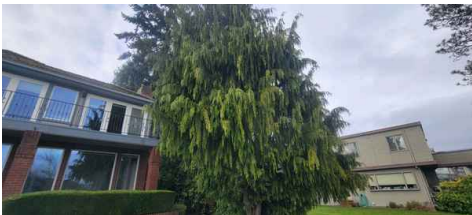
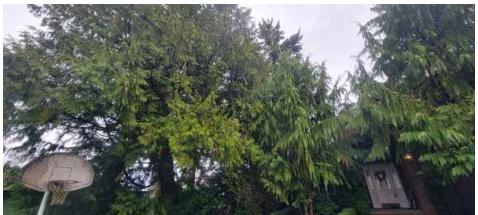
Various Locations

TREE HEALTH

Evaluation of tree health and life span is outside the scope of a standard home inspection. Several trees exist in the vicinity of this home. For further technical service I recommend a qualified arborist evaluate tree health as needed.
