KEY INSPECTION SERVICES, LLC

INSPECTION REPORT COPY

8220 SE 59th St
Mercer Island, WA 98040

03/15/2024

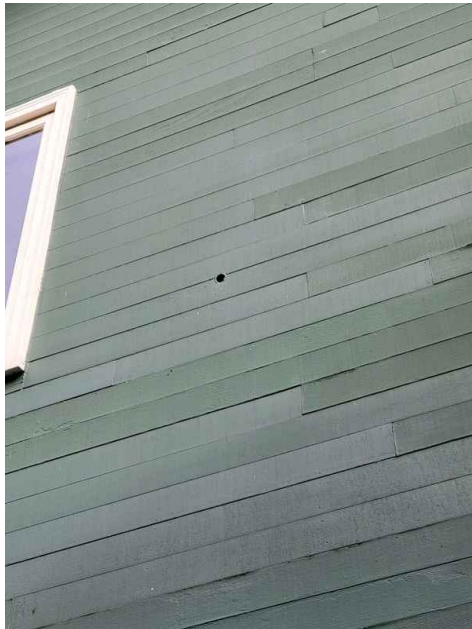
Left Side

Penetrations in the siding did not appear to be properly sealed. This may potentially allow moisture or pest intrusion. I recommend a qualified contractor to properly seal the areas.

Contact a qualified general contractor.

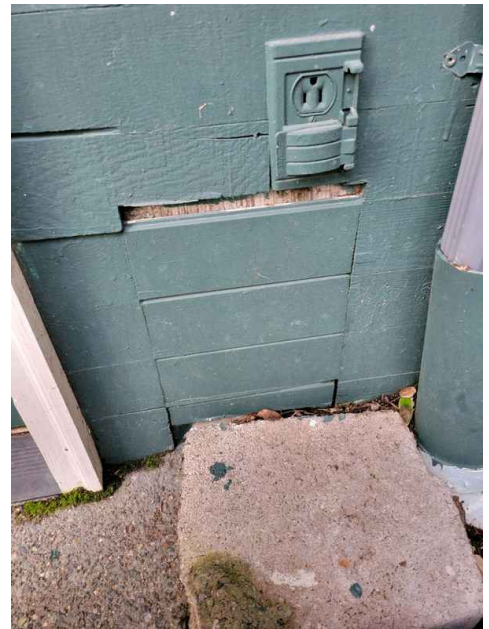
Front

GAP IN SIDING

There appears to be a gap in the siding which may indicate a previous repair. To prevent moisture intrusion of the homes sheathing, I recommend a qualified siding contractor evaluate for repair.

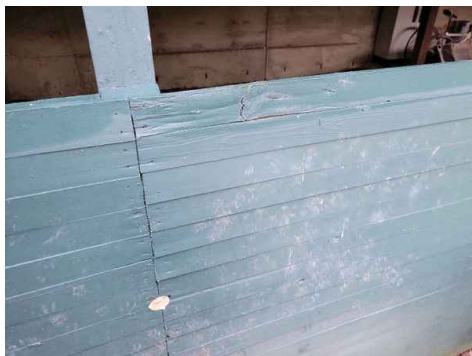
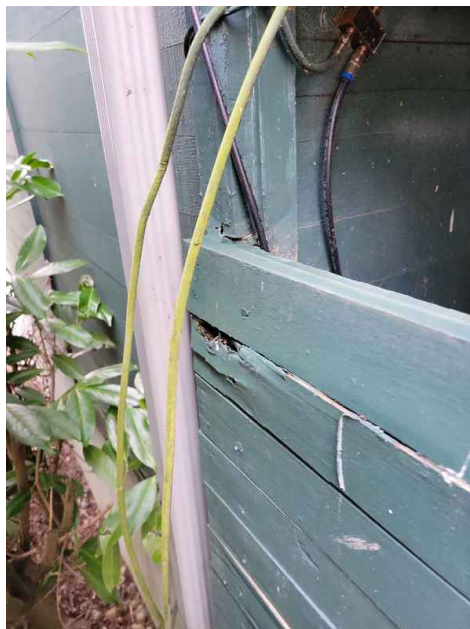
Rear

WOOD DETERIORATION

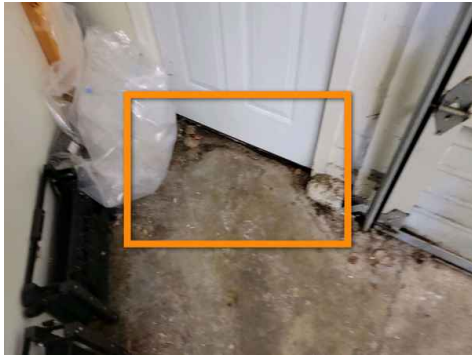
Garage Front

MOISTURE AT GARAGE ENTRANCE DOOR

Signs of moisture was noted at the floor near the front garage door, deterioration of the door and frame was also noted. I recommend a qualified door installation contractor evaluate for repairs.

Contact a qualified door repair/installation contractor.

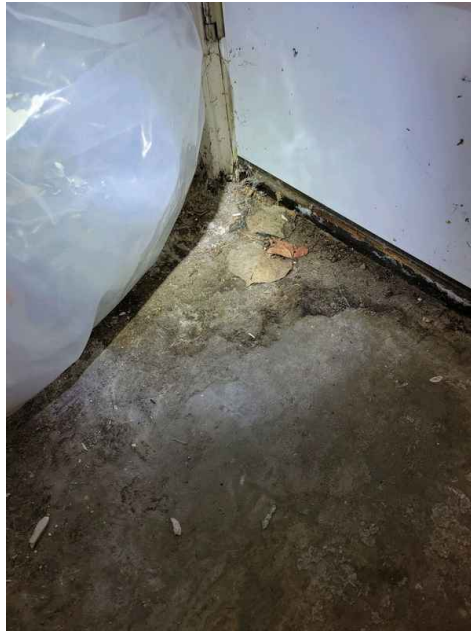
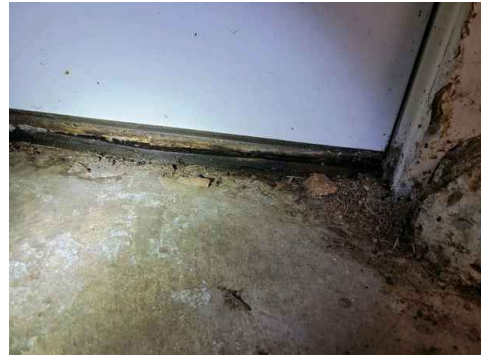
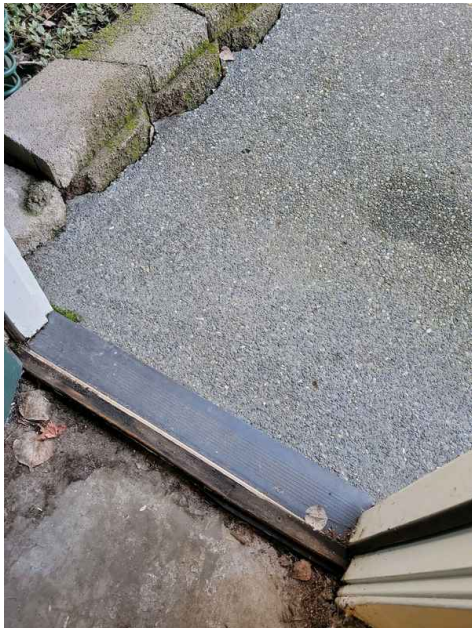
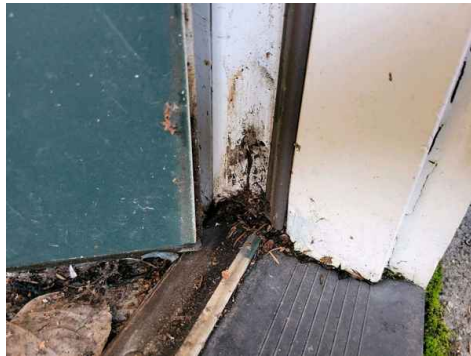
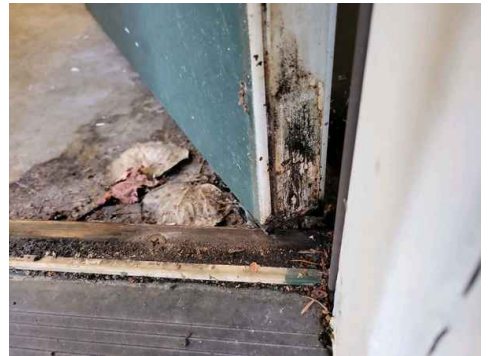
Garage Front

4.2.1 Exterior Doors

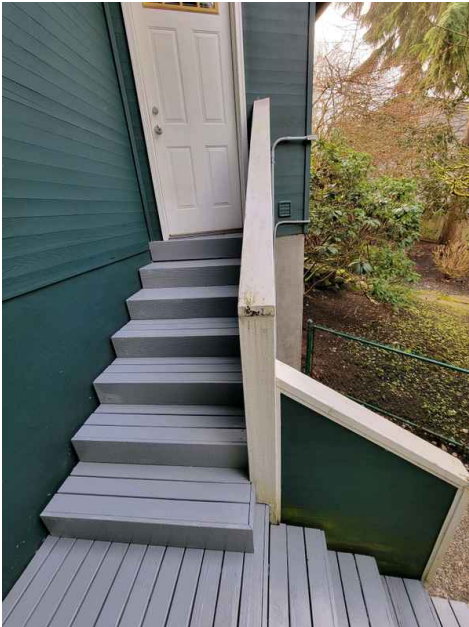
Left Side

Although it may have not been necessarily required when the home was constructed, I recommend having a qualified contractor install a graspable handrail for increased safety. Graspable handrails allow someone to ascend or descend the staircase safely should someone trip or begin to fall.

Contact a qualified carpenter.

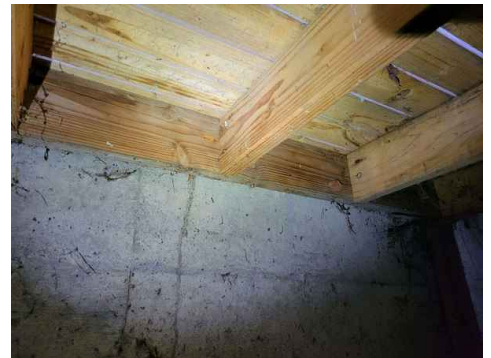
The stairway platform appeared to be missing several components. Missing hangers at the joists, missing lag bolts at the ledger board, and missing flashing at the ledger board were all noted. I recommend a qualified contractor evaluate for repair.

Contact a qualified professional.

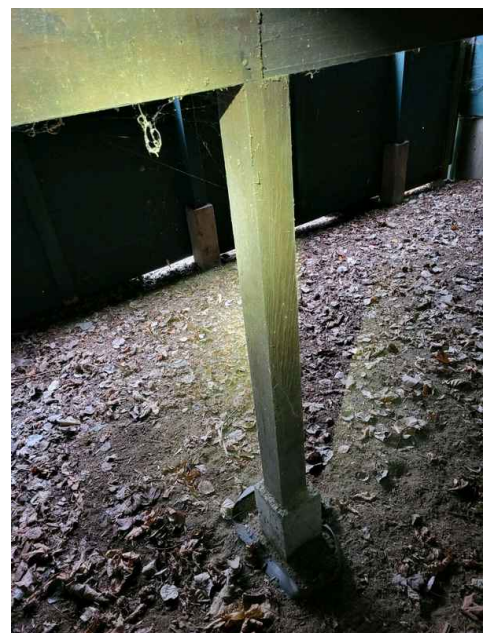
DECK POSITIVE CONNECTION MISSING

Deck post did not appear to have a positive connection at the time of inspection. Recommend a qualified decking contractor to evaluate for repair replacement for increased safety.

Contact a qualified deck contractor.

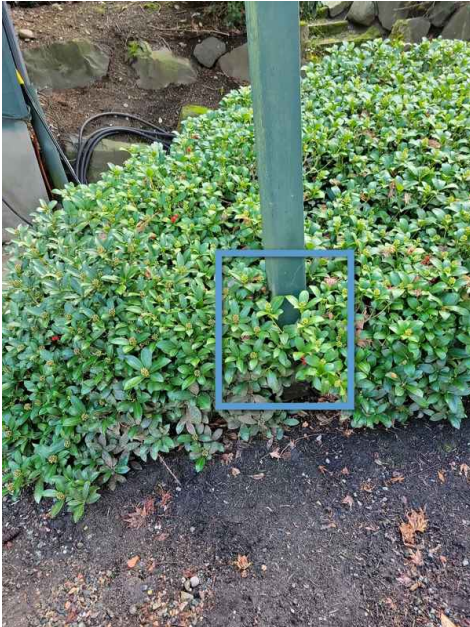
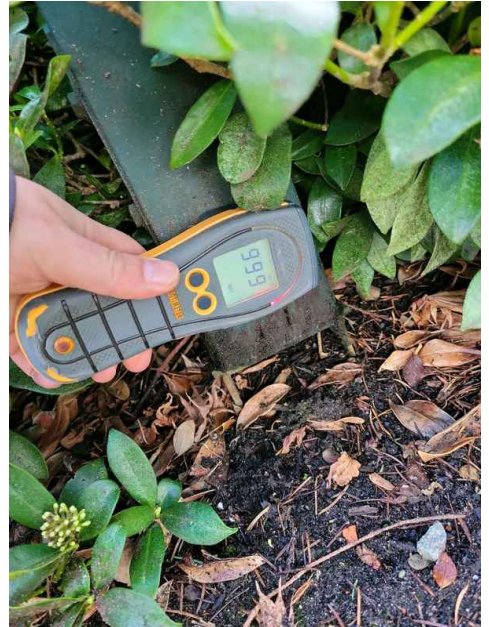
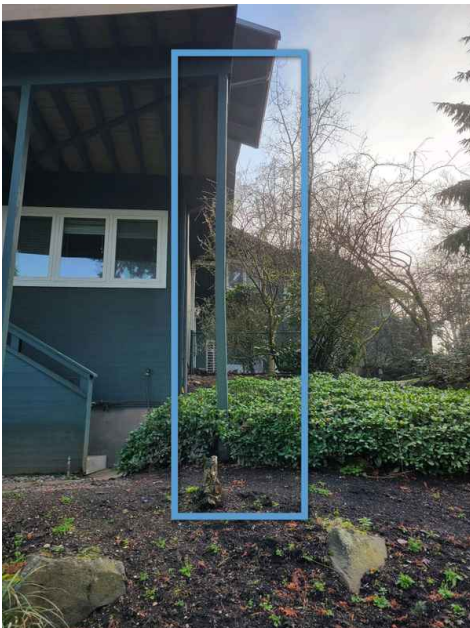
Rear

Deck post was showing signs of wood deterioration and appeared to be bowing at the time of the inspection. A contractor was in the process of replacing the post during the inspection.

Elevated moisture reading

Contact a qualified deck contractor.

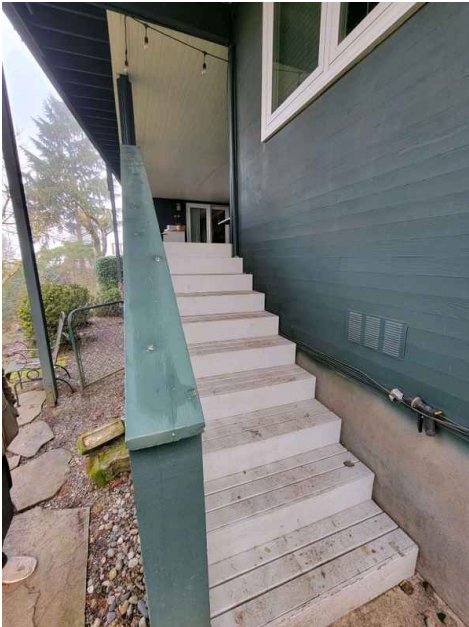
Rear

For increased safety, I recommend that a qualified contractor install a graspable handrail.

Contact a qualified professional.

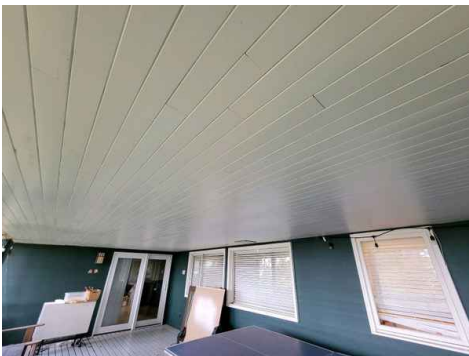
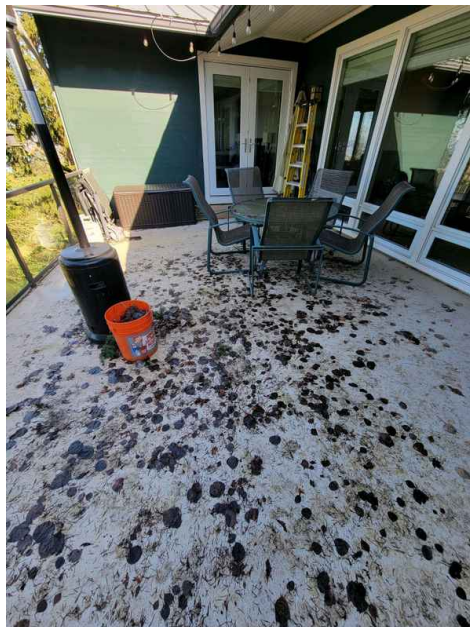
Inquire with seller regarding the history and operation of sealed decking system. The system is not accessible from the area below. Sealed decking systems need continual sealant and moisture control to prevent wood deterioration of underlying structure.

Contact a qualified deck contractor.

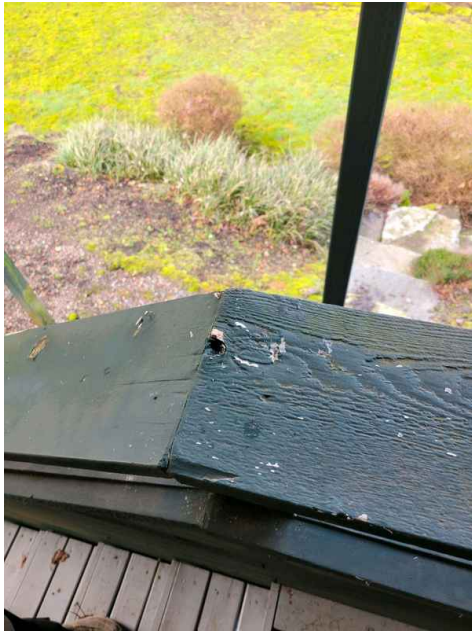
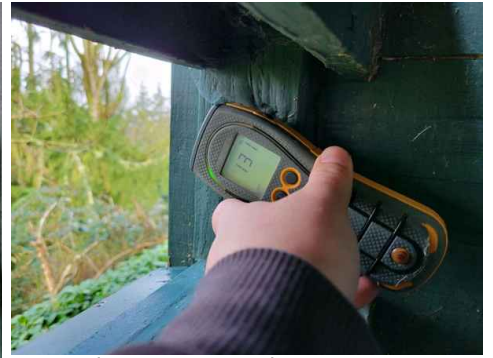
Lower deck

GUARDRAIL MINOR DETERIORATION

Minor deterioration of the guardrail noted at the lower deck, no elevated moisture was noted at the time of the inspection. I recommend a qualified contractor evaluate for repair or replacement.

Normal moisture readings

Contact a qualified professional.

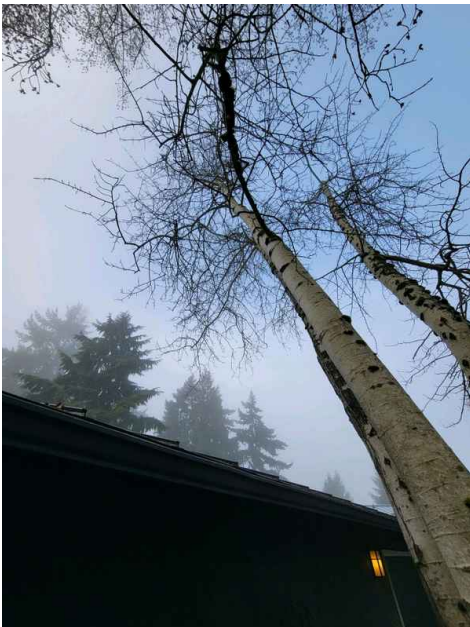
Garage

Trees observed overhanging the roof. This can create shady areas on the roof which can lead to moss growth and excessive debris on the roof covering. It can also allow rodents to access the roof and attic. Recommend a qualified tree service trim the overhang.

Contact a qualified tree service company.

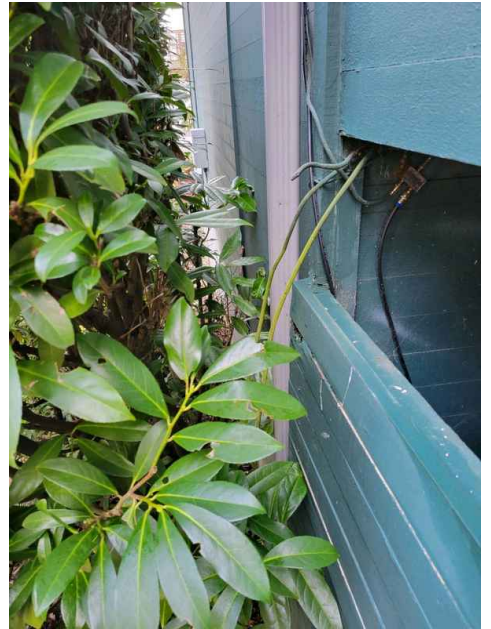
Rear

We recommend maintaining a 12" clearance between vegetation and the structure, and a minimum 4" clearance between soil and wood products to avoid conducive conditions for rodent entry and/or wood destroying organisms as well as wood rot. Areas covered by vegetation were not visible for inspection. Not all pictures represent all vegetation in contact with the structure.

Contact a qualified landscaping contractor

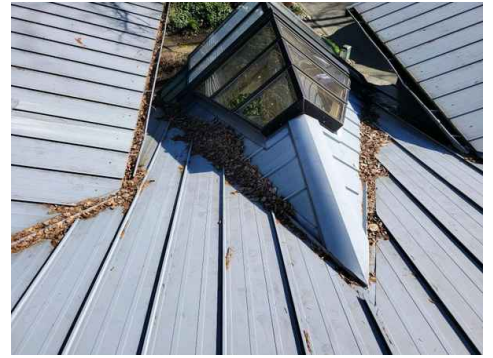
Debris is accumulating on the roof in one or more locations. All debris should be removed to ensure proper drainage. These areas should be kept clear to reduce the potential for backups and possible water penetration into the structure. I also recommend that a qualified roofing contractor evaluate the entire roofing system after the debris has been removed for repairs/replacement.

Contact a qualified roofing professional.

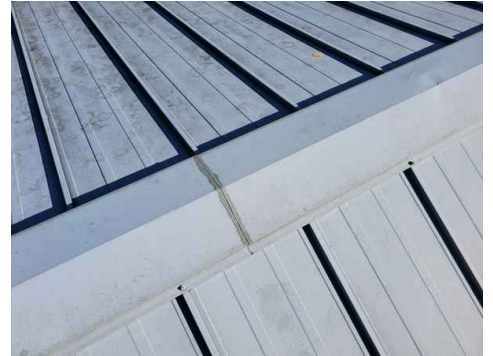
Garage

Additional sealant noted on the roof, this is typically an indication of a previous roof leak. The sealant appears to be aged and no longer performing its intended function. No elevated moisture or staining was noted in the attic. I recommend inquiring with the seller on any previous roof leaks or repairs to the roof that have been performed.

Contact the seller for more info

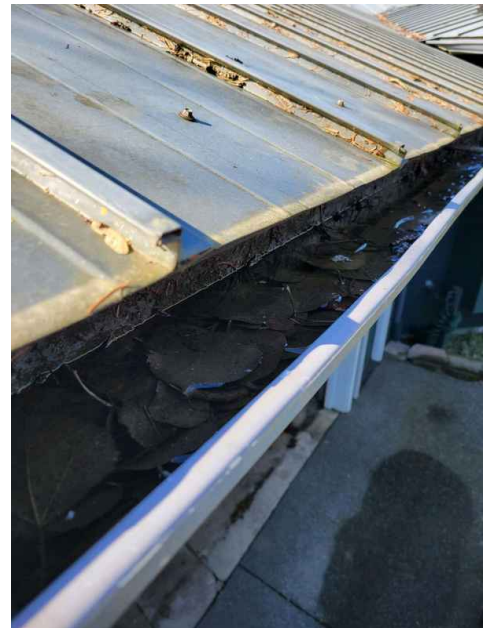
Excessive debris noted in gutters at time of inspection. It is common maintenance of a house to have the gutters cleaned once or twice a year. Recommend cleaning to facilitate water flow.

Contact a handyman or DIY project

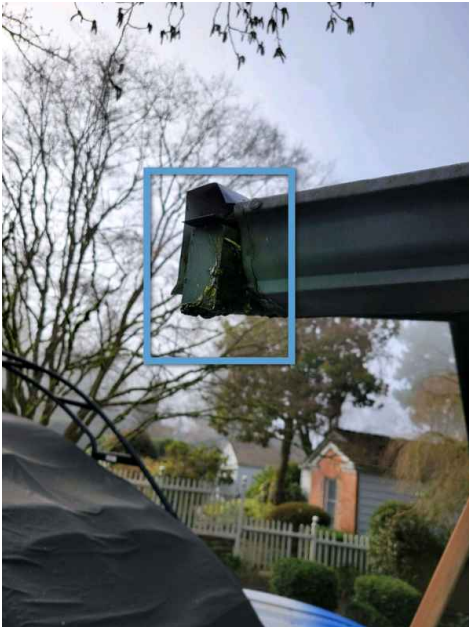
Front Left Side

GUTTER LEAKING

The gutter appeared to be leaking. Leaking gutters may create rot or damage to the foundation. I recommend a gutter specialist to repair or replace the gutter.

Contact a qualified gutter contractor

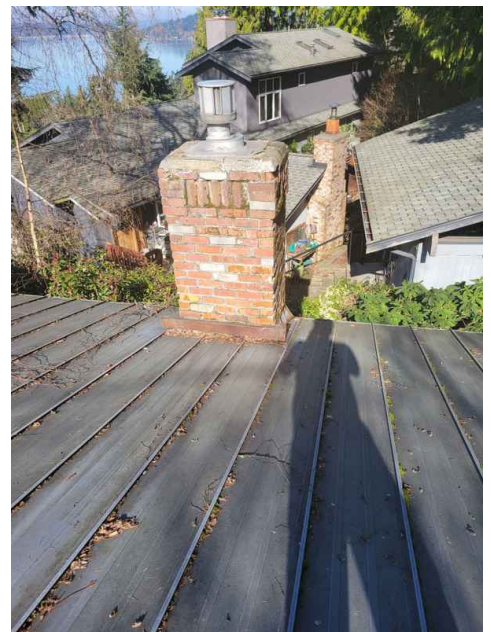
Right Side

CRICKET FLASHING MISSING

The flashing used to divert water around a chimney larger than 3 feet in width was missing. This can lead to moisture intrusion at the critical roof to chimney intersection. Recommend evaluation and repair by a qualified roofing contractor.

Contact a qualified roofing professional.

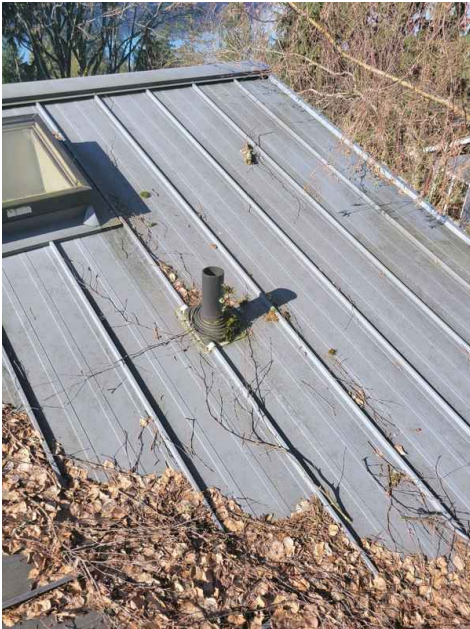
Right Side

The flashing for a plumbing vent appears to overlap with one of the ribs of the metal roof. Flashing in areas like this have a higher tendency to leak. No signs of leaking were noted during the inspection. It is recommend that you monitor this area after heavy rains to determine if the flashing has begun to leak.

Recommend monitoring.

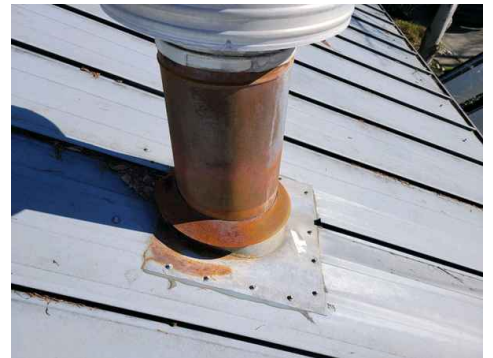
Right Side Front

METAL FLUE RUSTED

The metal flue pipe appeared to be rusted above the roof line. I recommend that a qualified HVAC or chimney contractor repair/replace as necessary to deter moisture intrusion.

Contact a qualified HVAC professional.

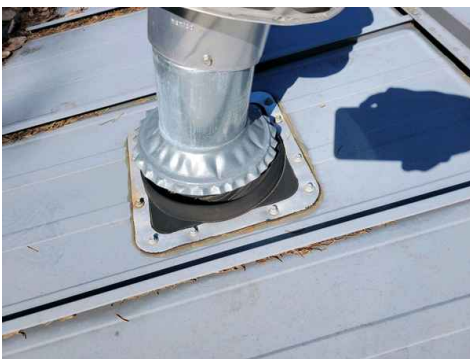
Rear Left Side

Aged/missing sealant at the storm collar of the gas appliance flue pipe. I recommend that a qualified professional seal the collar to prevent moisture intrusion.

Contact a qualified HVAC professional.

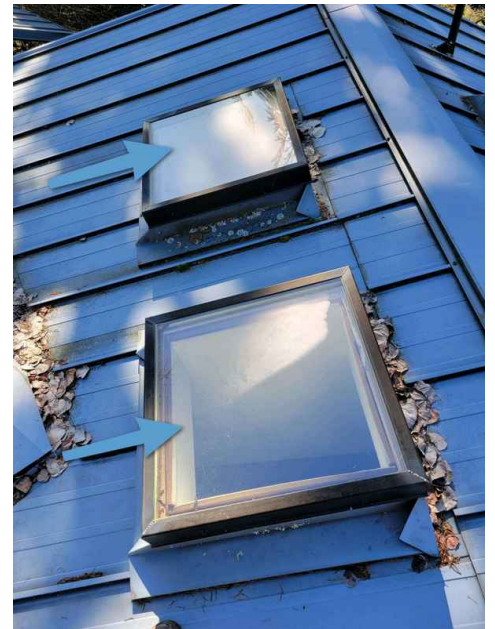
Front

5.4.3 Skylights & Other Roof Penetrations

Contact a qualified window repair/installation contractor.

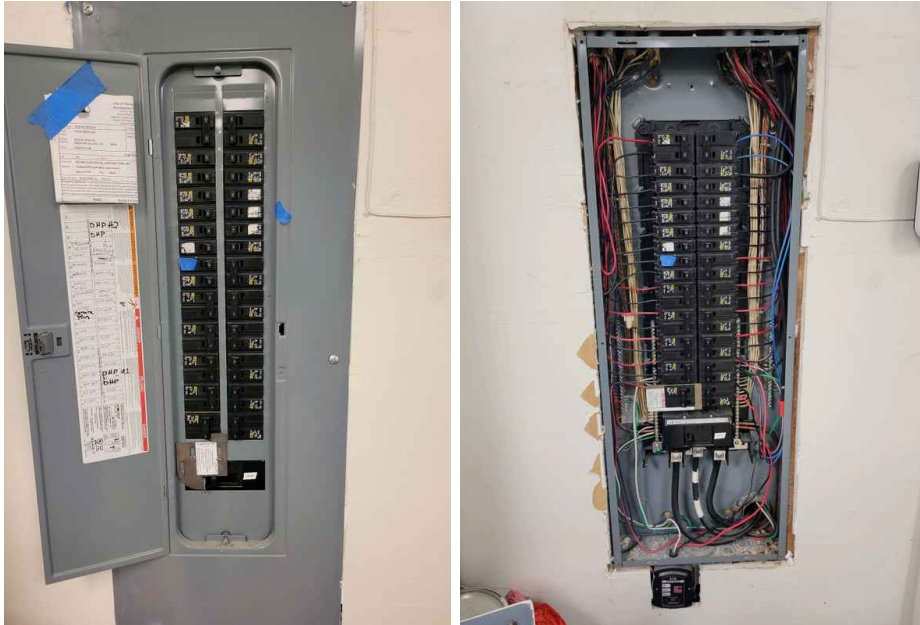
Main & Subpanels, Service & Grounding, Main Over current Device: Main Electrical Shut-off Location Garage

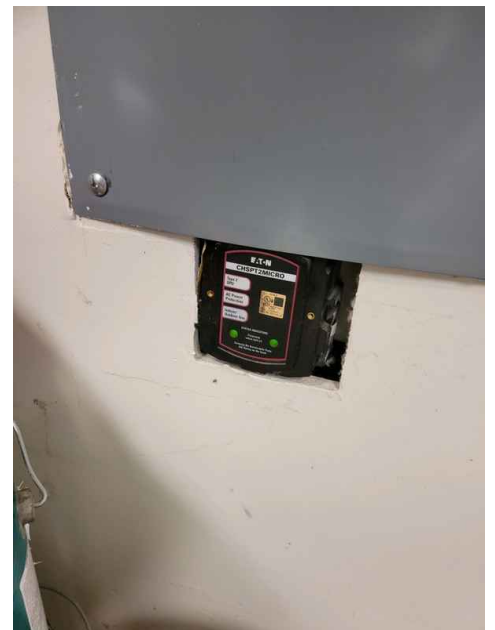
SURGE PROTECTORS NOT INSPECTED

Surge Protectors can not properly be test by normal methods to ensure there operability. For further technical support I recommend contacting an electrician.

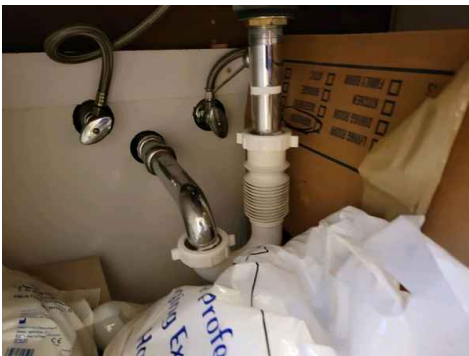
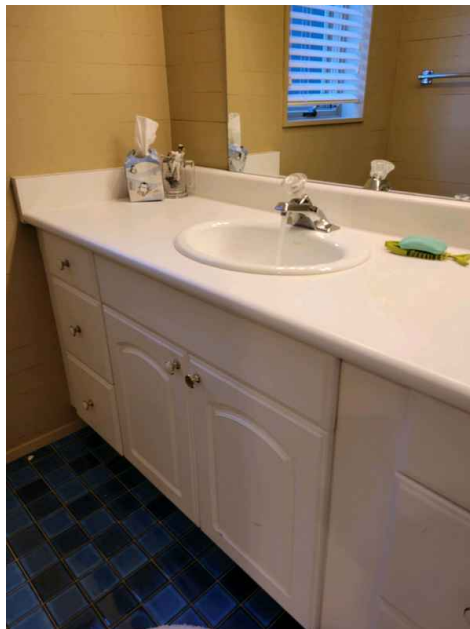
1st Floor Bathroom

9.4.1 Sink

Contact a qualified plumbing contractor.

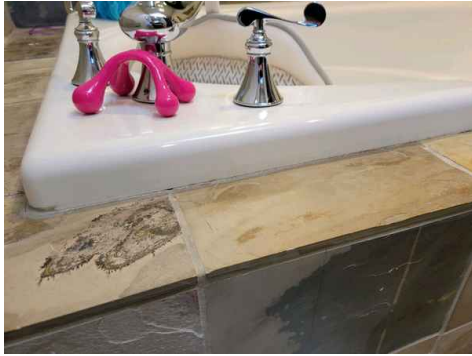
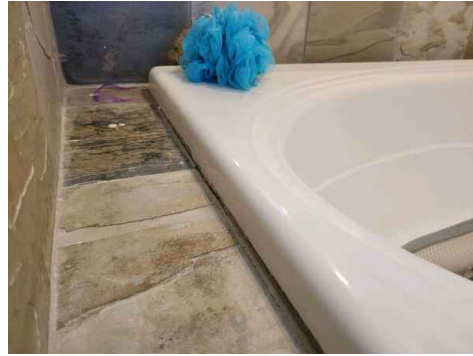
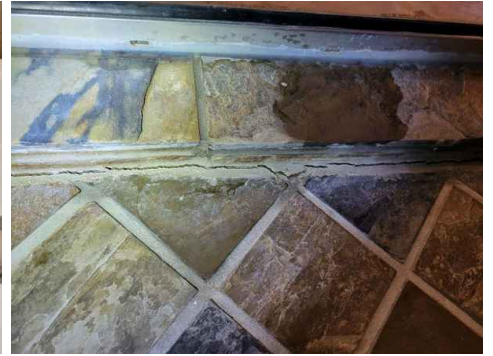
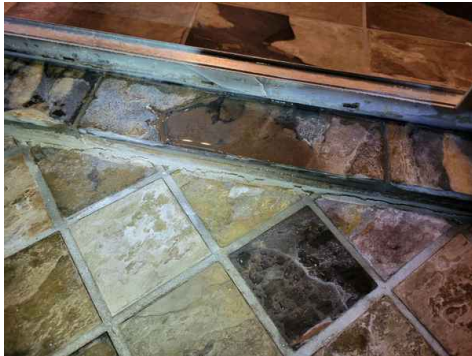
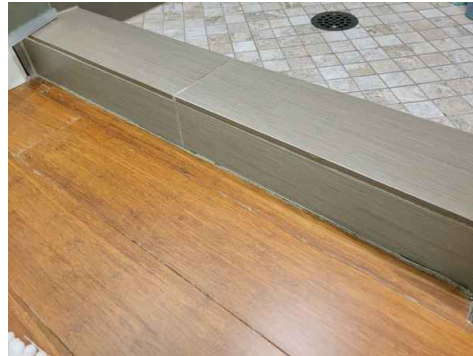
CAULKING DAMAGED/MISSING

There appeared to be missing/damaged caulking in the shower area. This is a common, deferred maintenance issue for homeowners. I recommend repair/replace to prevent any moisture intrusion to the underlying wall and floor structures.

Contact a handyman or DIY project

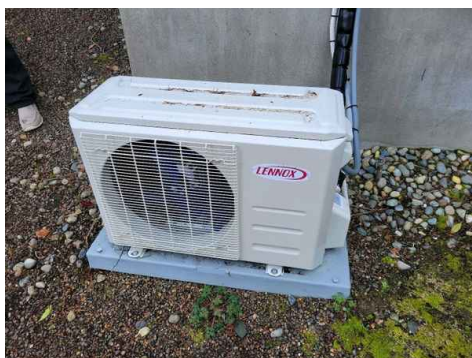
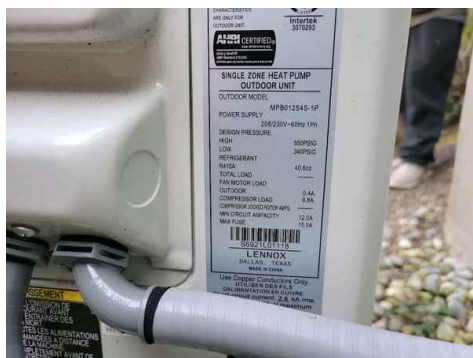
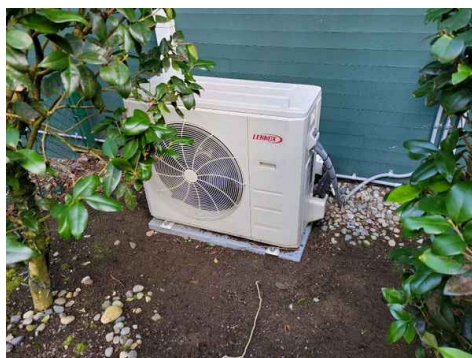
Left Side

HEAT PUMP - RECOMMEND SERVICING

Home has a heat pump heating/cooling system installed. These systems provide heat and cool air to the area of home that has the evaporator coil mounted. Following manufacturer's recommendations for service is recommended to ensure efficiency and air quality. Inquire with seller on most recent service of the system. I recommend the unit be properly serviced per manufacturer's recommendations if the unit has not been serviced in recent seasons.

Contact a qualified HVAC professional.

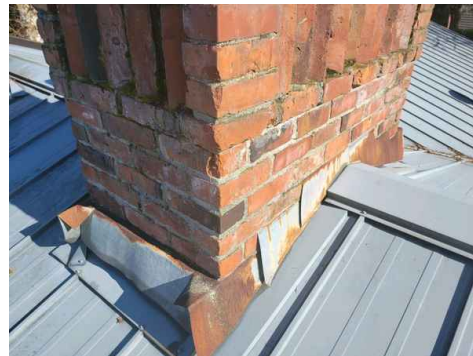
Center

SPALLING

Spalling noted on the bricks at the chimney. This occurs when moisture in the bricks freezes and the thaws. I recommend a qualified chimney specialist to repair/replace as necessary.

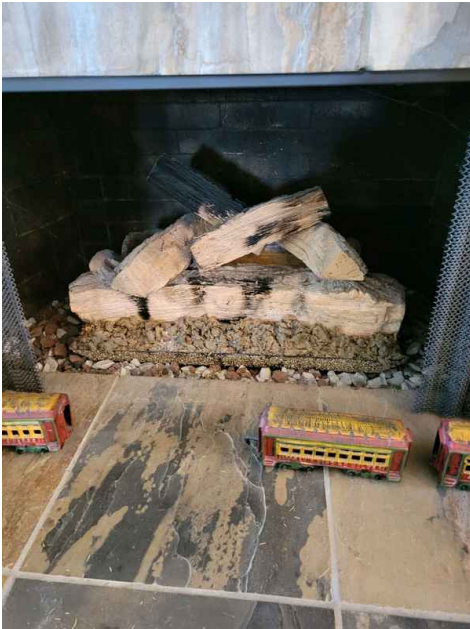
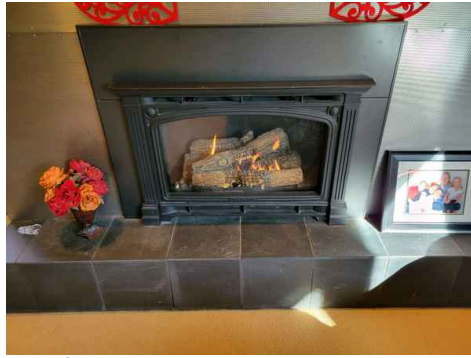
Family Room

12.2.1 Fireplace

Inquire with seller on history of servicing of the gas fireplace. We recommend regular service as per manufacturers specifications. Unable to determine when most recent service was performed.

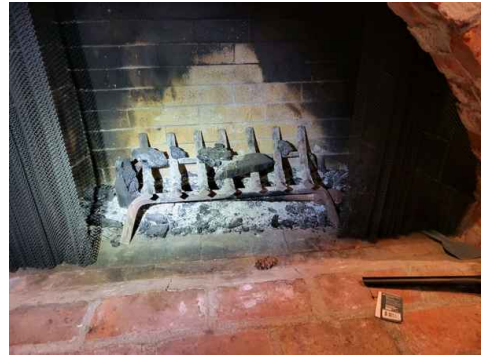
MISSING DAMPER LOCK OUT CLIP

The damper on the gas fireplace appeared to be missing a lockout clip to prevent the damper from being closed during fireplace. If the damper is closed during use, a build up of carbon monoxide can occur in the home. I recommend that a qualified contractor install a lockout clip for increased safety.

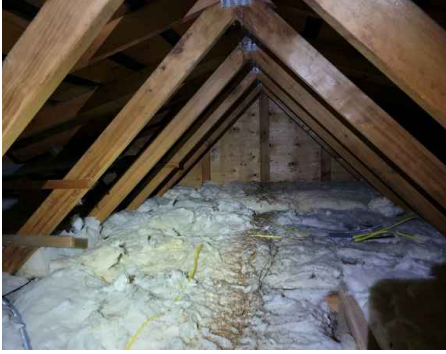
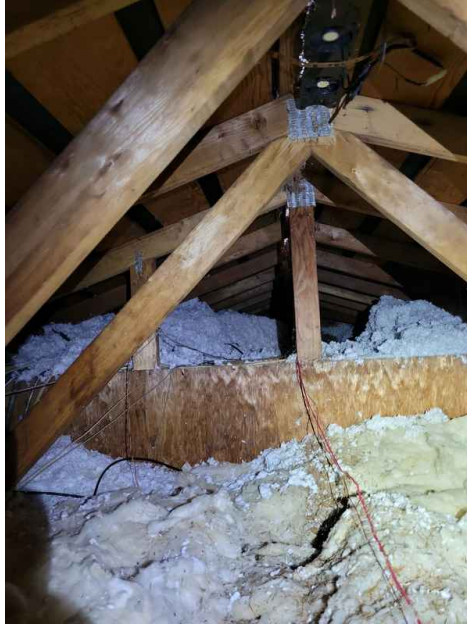
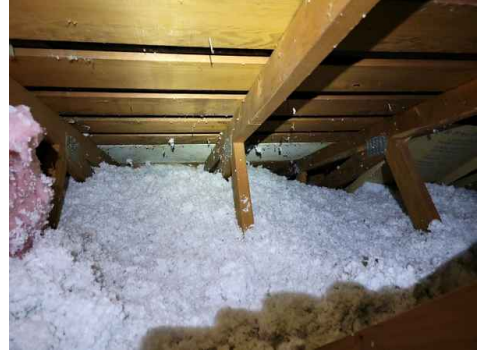
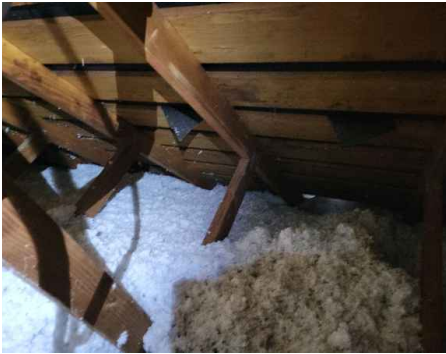
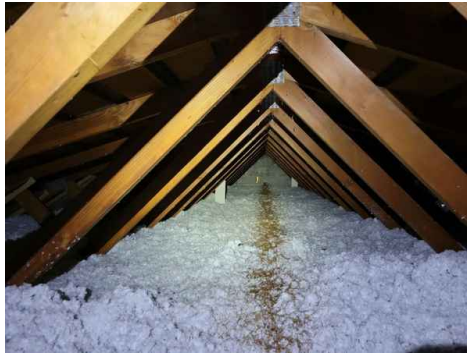
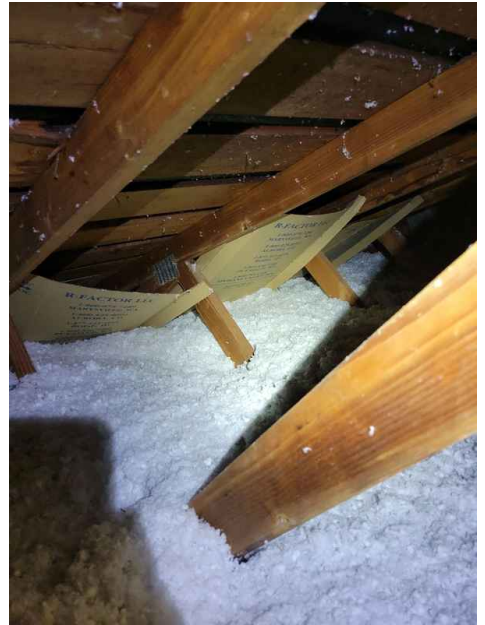
Roof Structure and Attic: Structural System

Trusses, Rafters

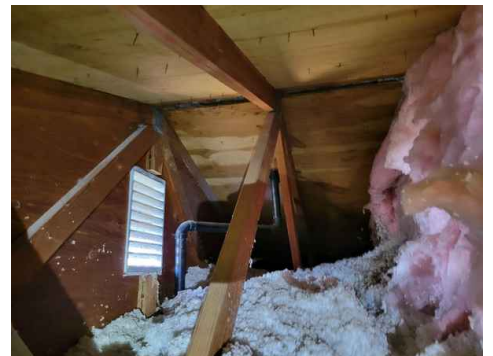
AREAS NOT ACCESSIBLE

Areas of the attic did not appear to be accessible due to any of the following conditions: debris, HVAC ducts, insulation, electrical wires, plumbing, hazards, fire suppression systems or clearance. I recommend inquiring with the seller about any history or maintenance to the attic area.

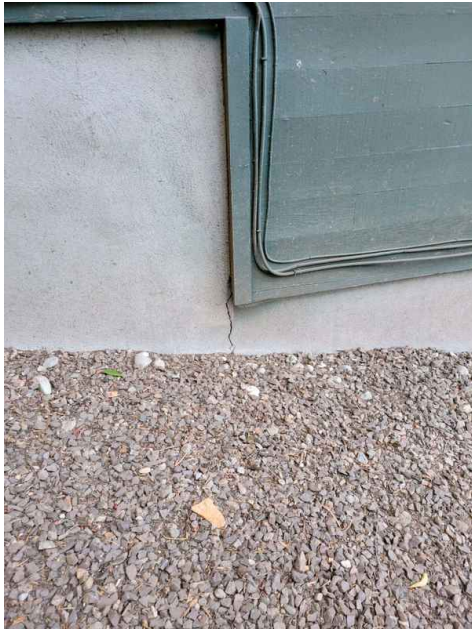
Right Side

FOUNDATION CRACKS - MINOR

Minor cracking was noted at the foundation. This is common as concrete ages and shrinkage surface cracks are normal. Recommend sealing the crack to prevent any further damages by a qualified concrete contractor.

Recommend monitoring.

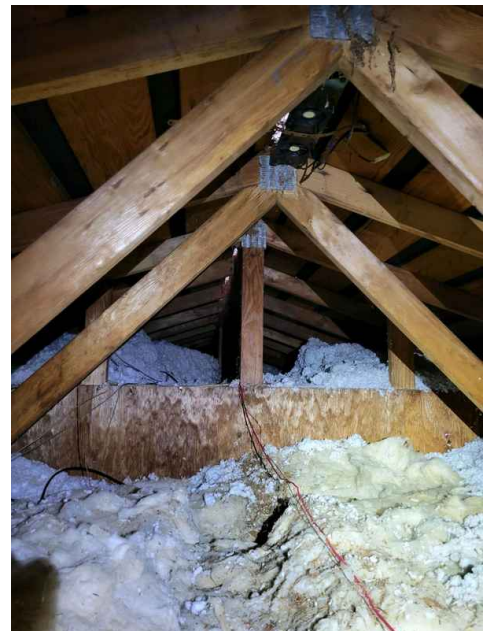
Although not necessarily required when the home was built, there should be a firewall between the attic space over the garage and the attic space to the adjoining main home. This is to deter the rapid spread of fire. For increased safety, I recommend evaluation and repair by qualified contractor.

Contact a qualified professional.

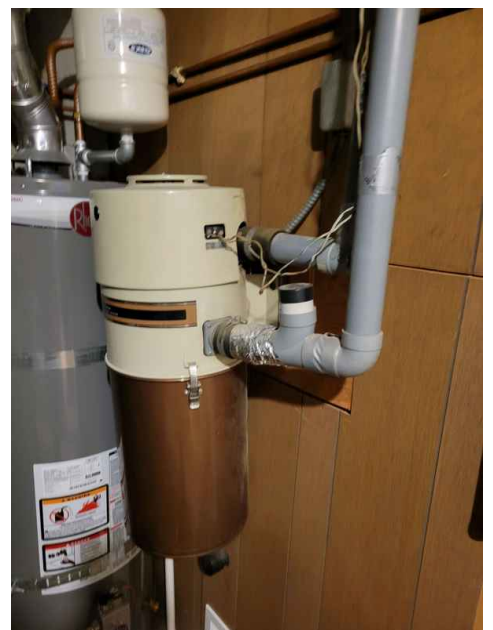
BUILT IN VACUUM

Built in vacuum systems are outside the scope of a standard home inspection. Recommend inquiring with seller for functionality.

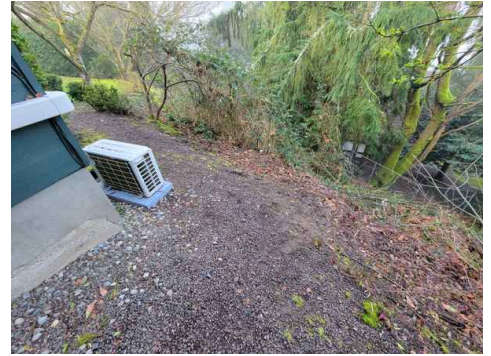
HILLSIDE STABILITY

This dwelling has been constructed on, or adjacent to, a hillside. An opinion on soil stability and potential movement may be available from a competent soil or geotechnical engineer who is familiar with conditions in this area. A competent specialist should be consulted, if specific information on the characteristics and performance of this particular hillside is desired.

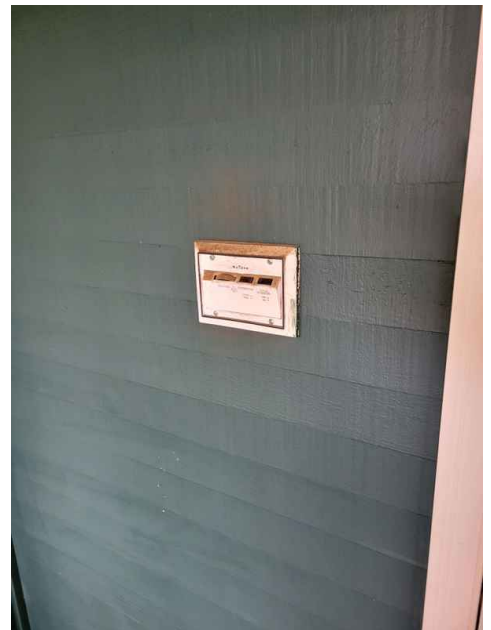
INTERCOM SYSTEM

The intercom system is not part of a standard home inspection. I recommend inquiring with the seller about any information on the system.

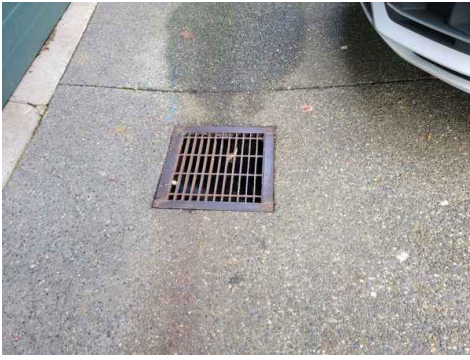
RAINWATER DRAINAGE SYSTEM

Rainwater drainage system noted in multiple locations at the exterior. Inspection of the systems is outside the scope of a standard home inspection. I recommend inquiring with builder and/or seller regarding installation and maintenance.

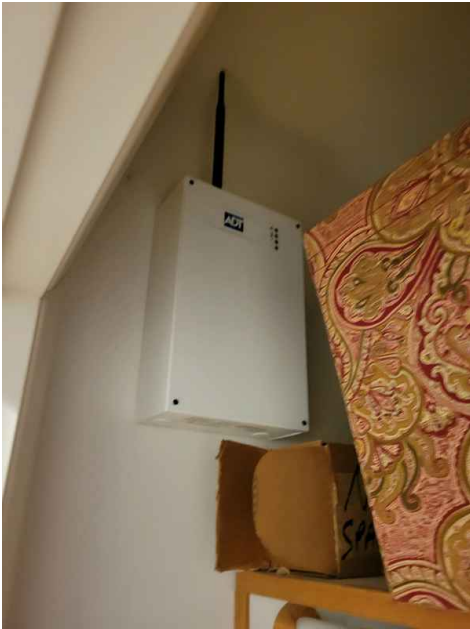
SECURITY SYSTEMS

Security systems are not part of a standard home inspection. Inquire with the seller for details on operation. For further technical information, I recommend contacting a home security system company.

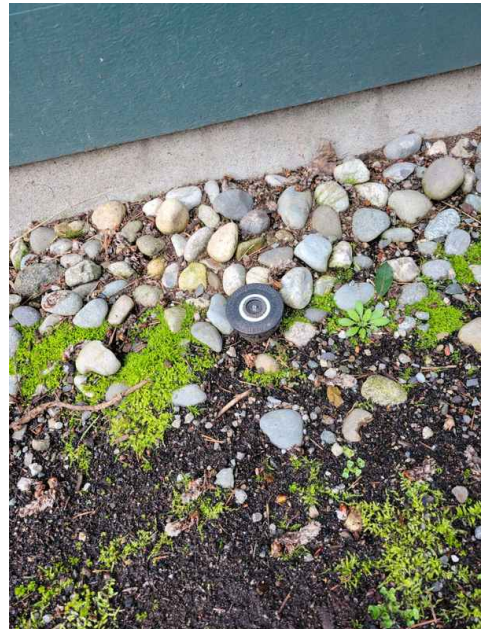
SPRINKLER SYSTEM

Sprinkler systems are outside the scope of a standard home inspection. I recommend inquiring with a seller about maintenance to this system. For further technical information I recommend a qualified landscaper to evaluate.
