MICHELE
SCHULER

13809 212TH DR NE, WOODINVILLE

**13809 212TH DR NE,
WOODINVILLE**

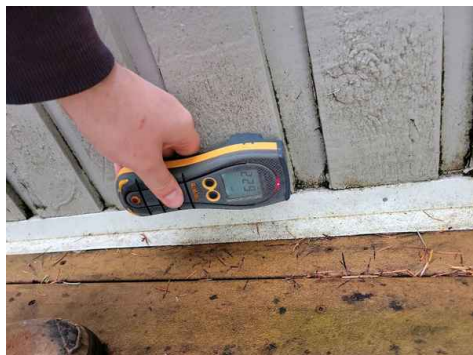
Elevated moisture reading

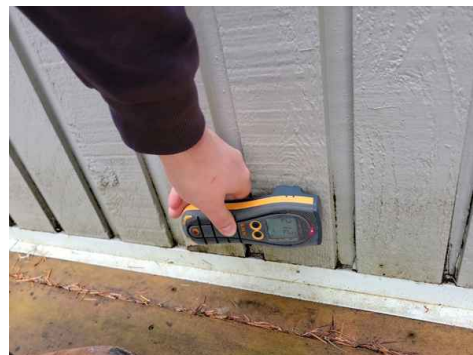
Elevated moisture reading

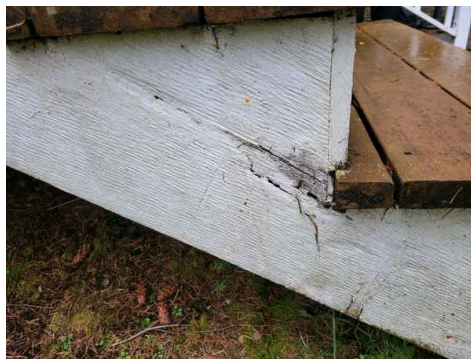
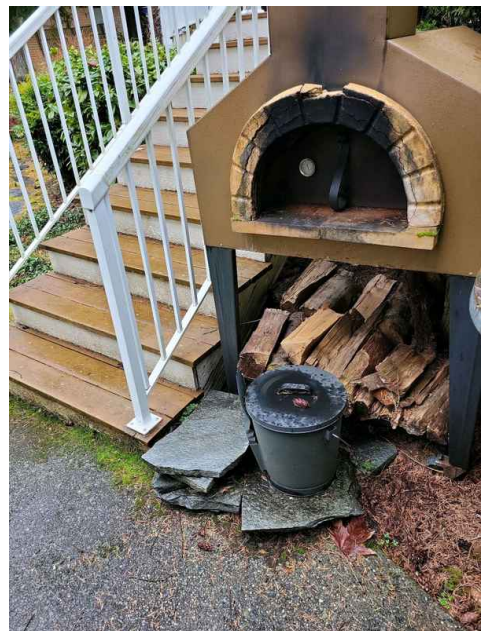
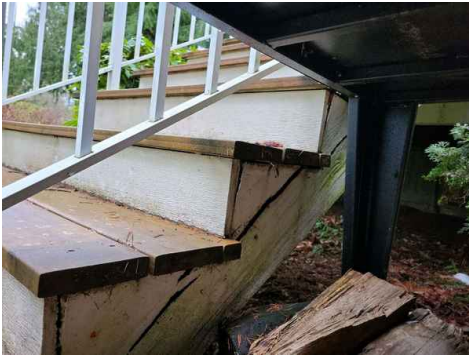
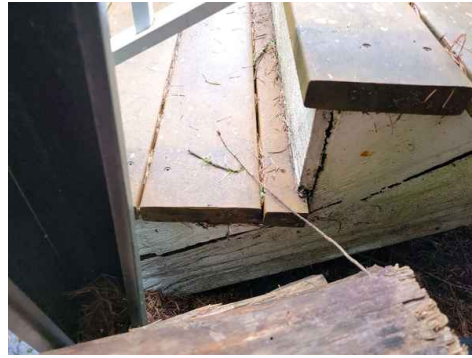
STAIRS - DETERIORATED

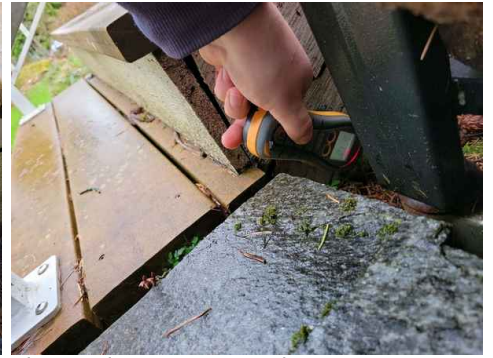
Elevated moisture reading

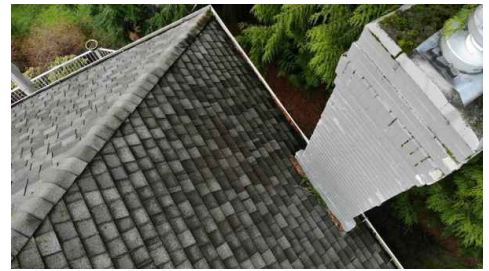
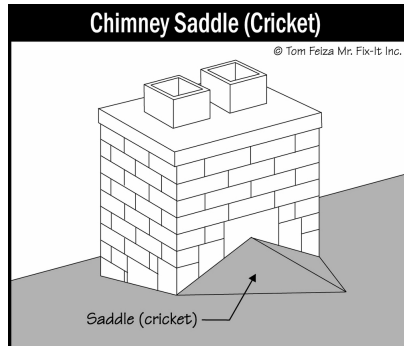
CRICKET FLASHING MISSING

The flashing used to divert water around a chimney larger than 3 feet in width was missing. This can lead to moisture intrusion at the critical roof to chimney intersection. Recommend evaluation and repair by a qualified roofing contractor.

Recommendation
Contact a qualified roofing professional.

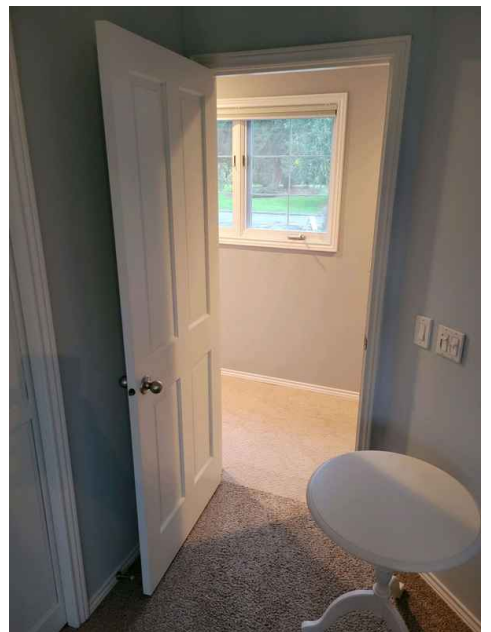
The door did not appear to latch properly. Minor adjustments may be needed at the strike plate. Recommend evaluation and repair by a qualified contractor.

Contact a qualified door repair/installation contractor.

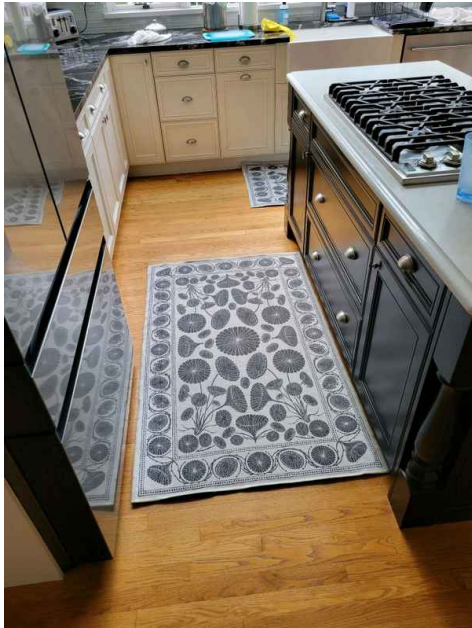
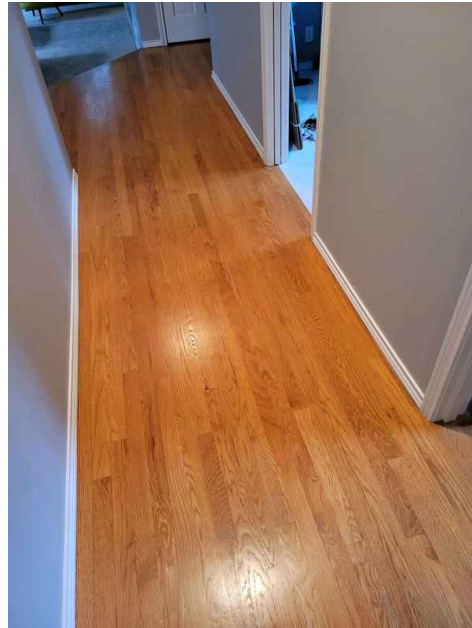
The flooring appeared to squeak when stepped on. It is common for a floor to start to squeak over time on any wood built home. A squeaking floor does not indicate a larger issue with the structure. This typically occurs over time when the weather changes and wood expands and contracts. I recommend that a qualified flooring specialist evaluate for repair as desired.

Contact a qualified professional.

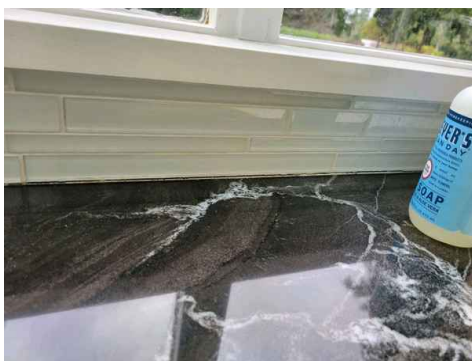
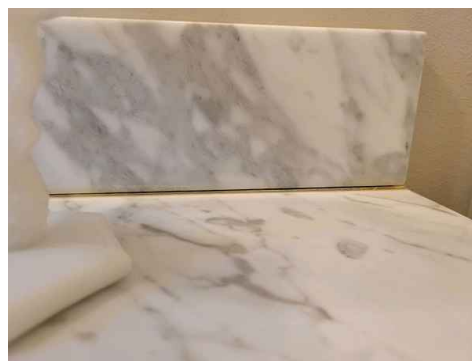
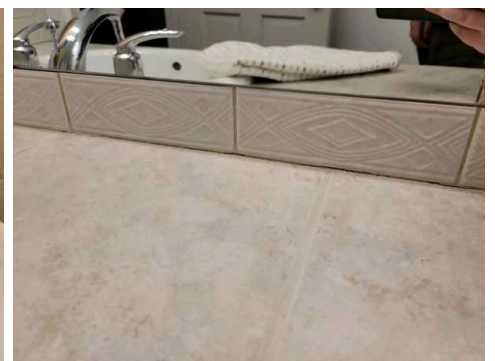
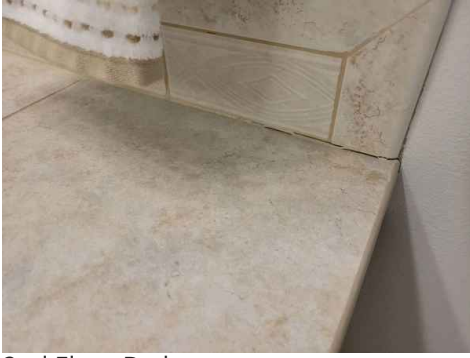
POOR/MISSING CAULK

Countertop was missing sufficient caulk/sealant. This can lead to water damage. Recommend adding sealant at sides and corners where counters touch walls. [Here is a helpful DIY video on caulking gaps.](#)

Recommended DIY Project

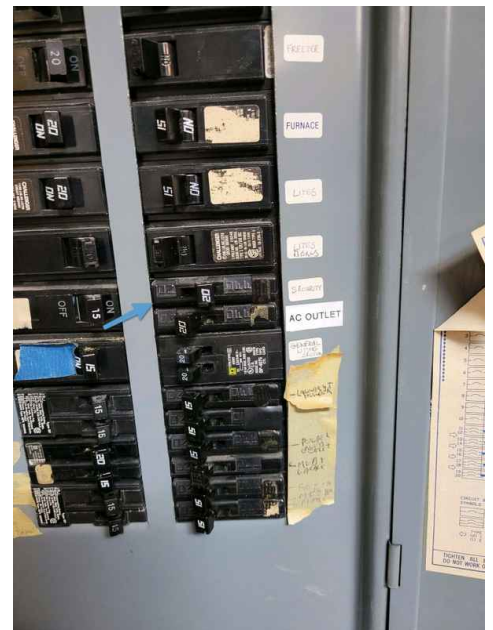
One of more breakers were in the OFF position in the electrical panel at the time of inspection. Inquire with seller regarding reason. For further technical assistance, I recommend evaluation by a qualified electrical contractor.

Contact a qualified professional.

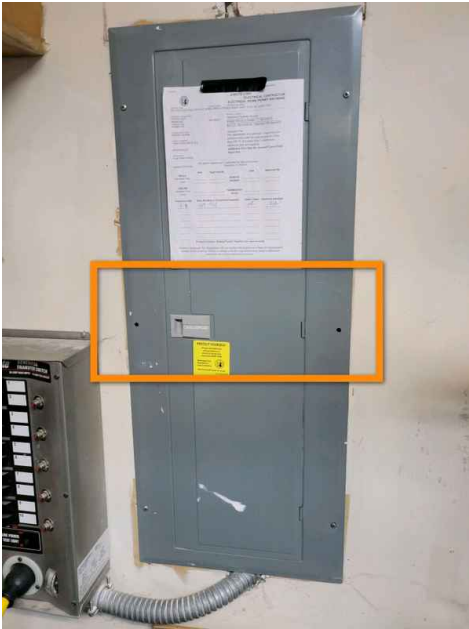
MISSING FASTENER

Missing fastener were noted. This creates a safety concern. I recommend simply adding proper fasteners to secure the panel cover.

Contact a qualified electrical contractor.

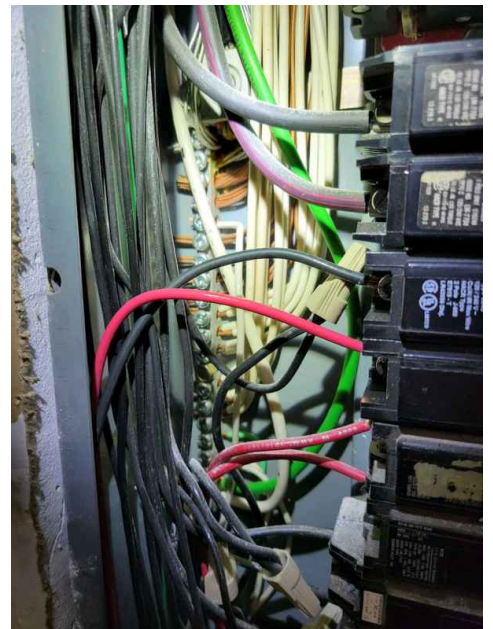
There appeared to be one or more double taps of neutral wires. This poses a potential safety hazard to someone working on the panel as well as increases chances for the neutrals to become loose. Recommend a qualified electrician to evaluate for repair replacement.

Contact a qualified electrical contractor.

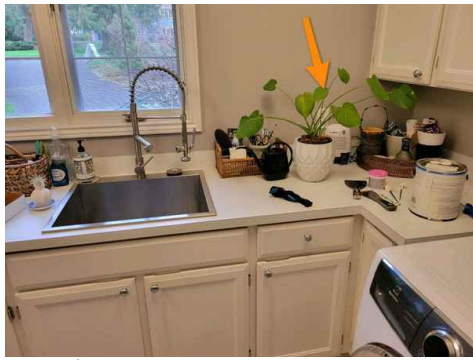
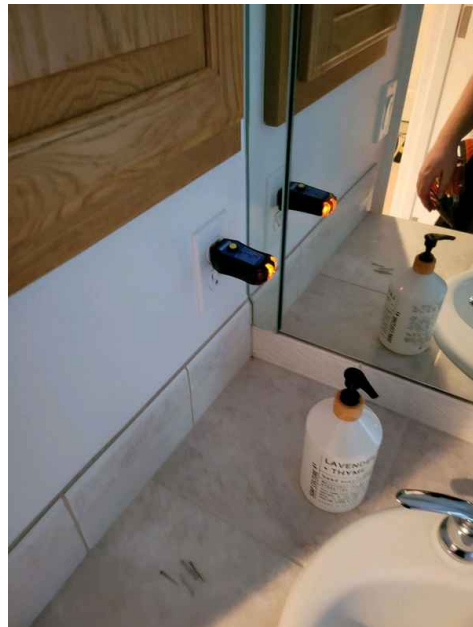
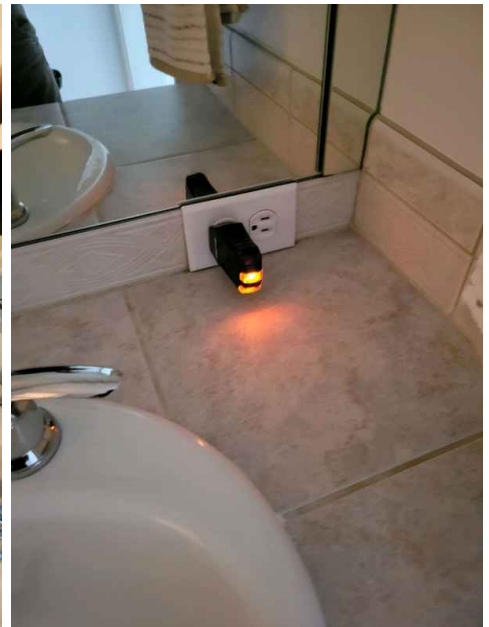
Although not necessarily required when home was built, we recommend that all outlets in close proximity to water (kitchen, exterior, bathrooms, garage, etc.) be protected by a Ground Fault Circuit Interrupter (GFCI) device. A GFCI is designed to detect an imbalance, or fault, in the electrical current and shut off the circuit before personal injury can occur. Recommend repair by a qualified electrical contractor.

Contact a qualified electrical contractor.

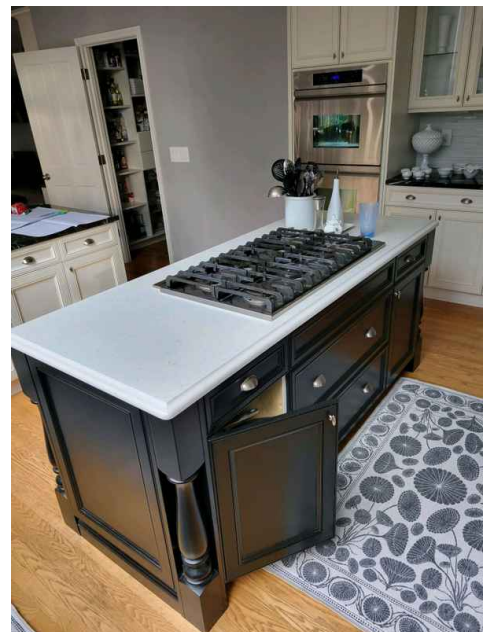
ISLAND MISSING OUTLET

There was no electrical outlet installed at the kitchen island. This presents a safety hazard if countertop appliance cords cross the kitchen aisle way and a person accidentally pulls the appliance off of the island. I recommend a qualified electrician to evaluate for repair/replacement.

Contact a qualified electrical contractor.

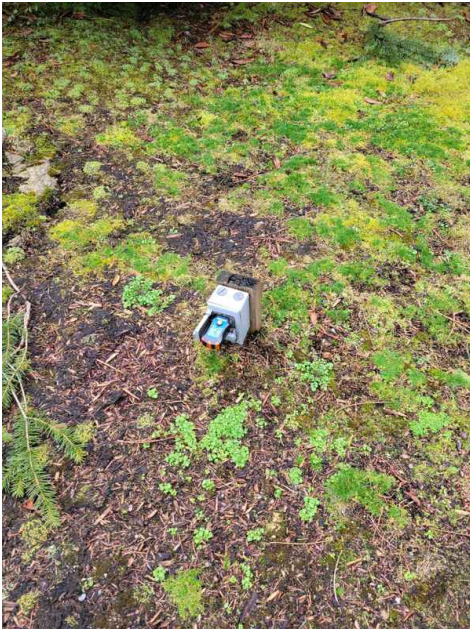
Front

There did not appear to be power at one or more outlets at the time of inspection. Unknown to the inspector the reason for the condition. Inquire with the seller if there is a control for the yard power, contact a qualified electrical contractor if repairs are necessary.

Contact a qualified electrical contractor.

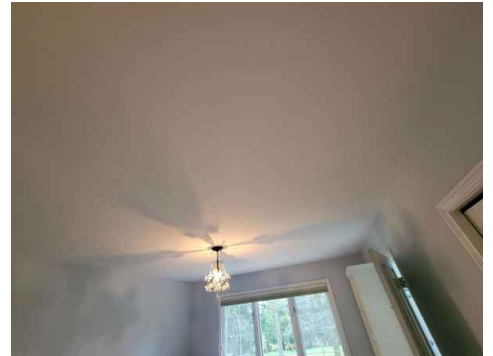
There appeared to be no smoke alarm found in one or more bedrooms. Recommend installing smoke alarms in required areas for increased safety in conformance with modern standards. For further Information visit: [U.S. Consumer Product Safety Commission](https://www.cpsc.gov/).

Contact a handyman or DIY project

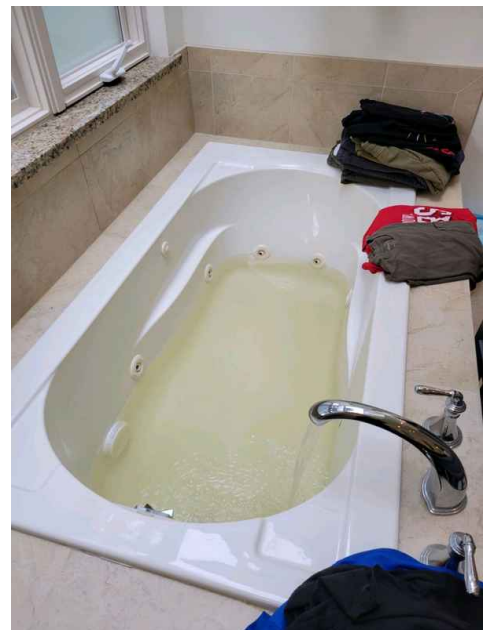
Primary Bathroom

The hot water appeared to be slightly discolored when run at a fixture for approx. 1 min. This may be due to a lack of use or from rust and sediment buildup. I recommend monitoring the tub to see if the condition continues. I also recommend evaluation and repair as desired/needed by a qualified professional.

Contact a qualified professional.

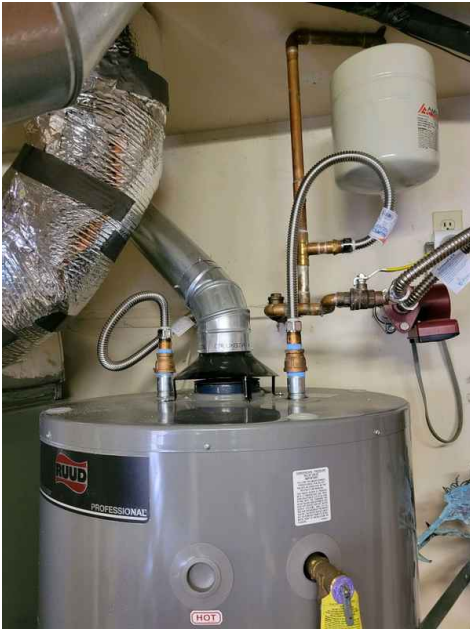
Missing insulation on plumbing pipes in one or more areas. Recommend insulating plumbing lines in crawlspace-garage-exterior to help deter freeze potential. Generally, a simple repair, but can be expensive if pipes burst.

Contact a qualified handyman.

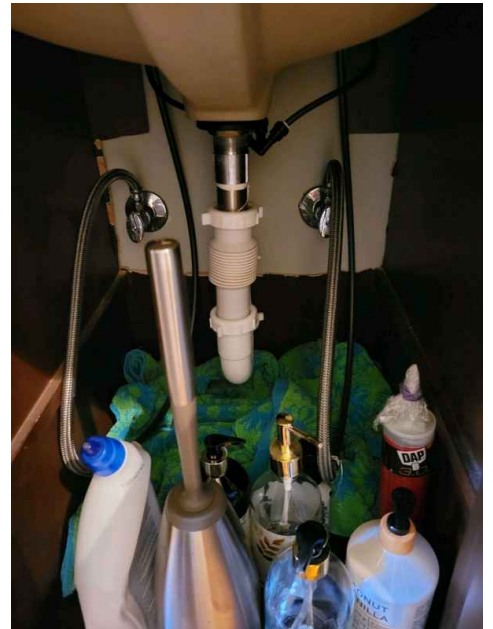
1st Floor Bathroom

There appeared to be corrugated plumbing drain/waste pipes installed at the sink. This type of plumbing pipe is a non-standard installation as the interior of the plumbing pipe is not smooth and therefore prone to clogs. I recommend a qualified plumber to evaluate for repair/replacement.

Contact a qualified plumbing contractor.

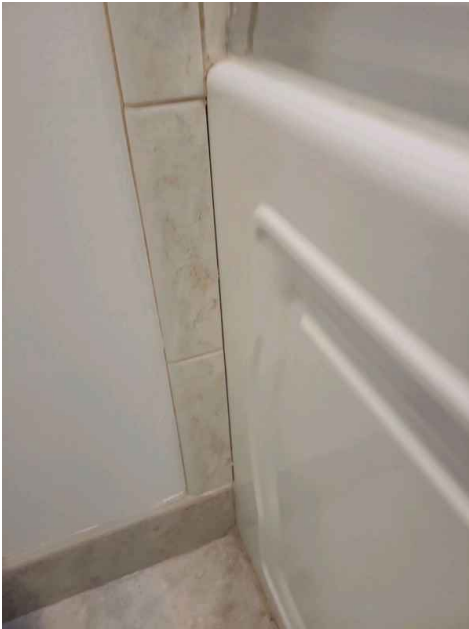
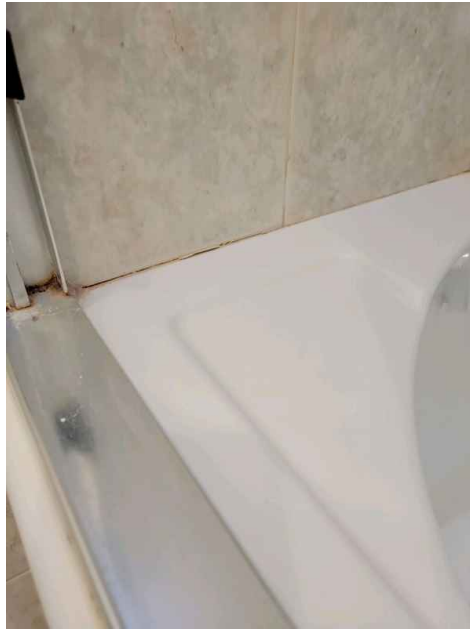
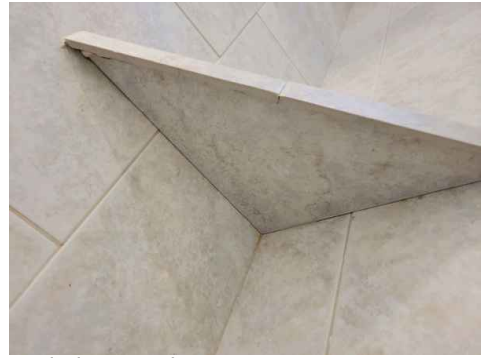
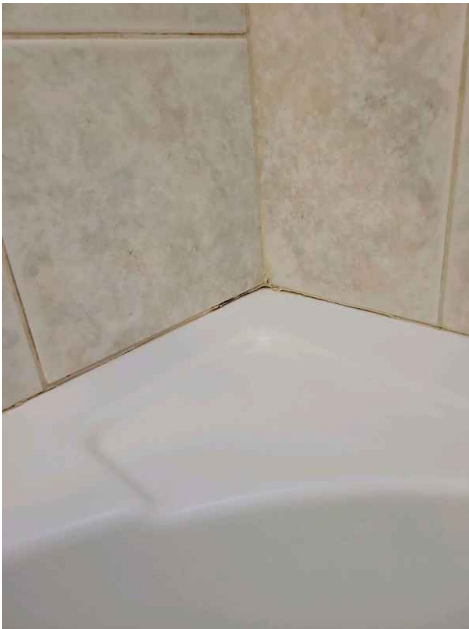
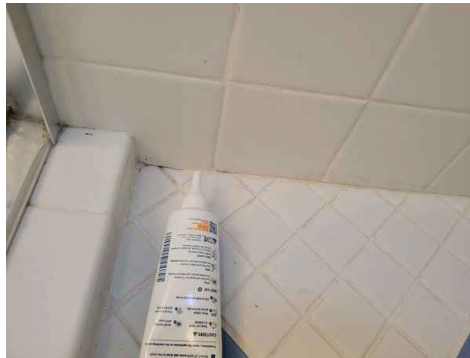
CAULKING DAMAGED/MISSING

There appeared to be missing/damaged caulking in the shower area. This is a common, deferred maintenance issue for homeowners. I recommend repair/replace to prevent any moisture intrusion to the underlying wall and floor structures.

Contact a handyman or DIY project

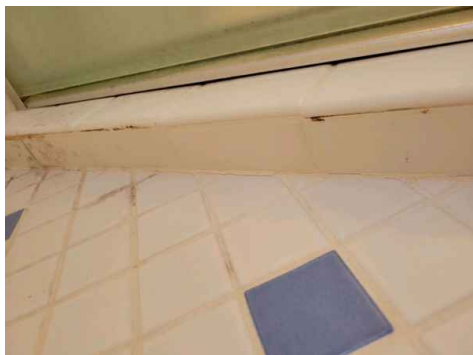
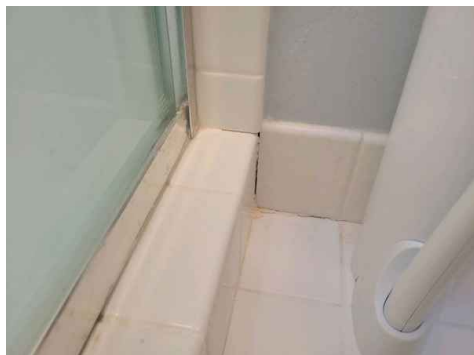
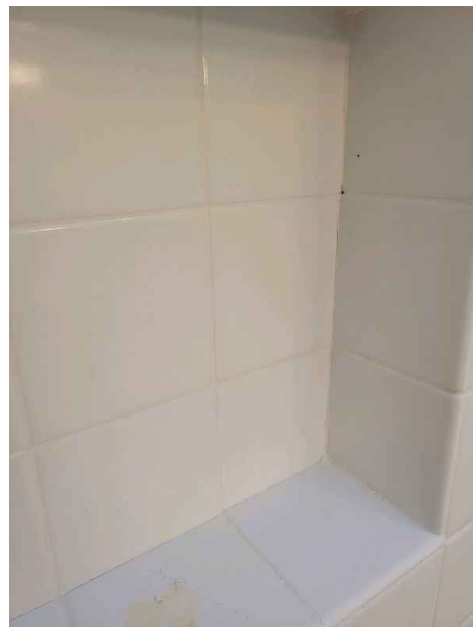
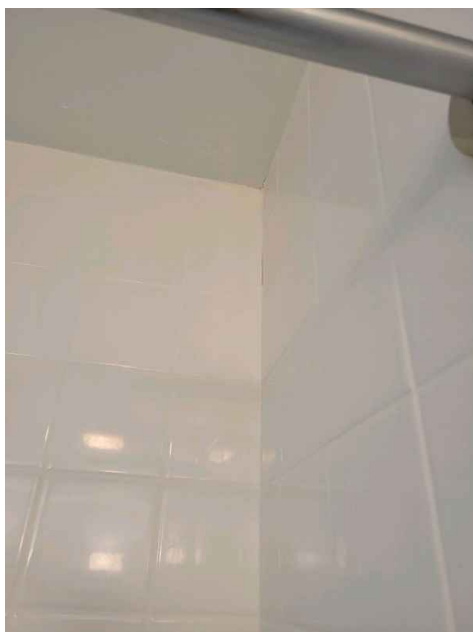
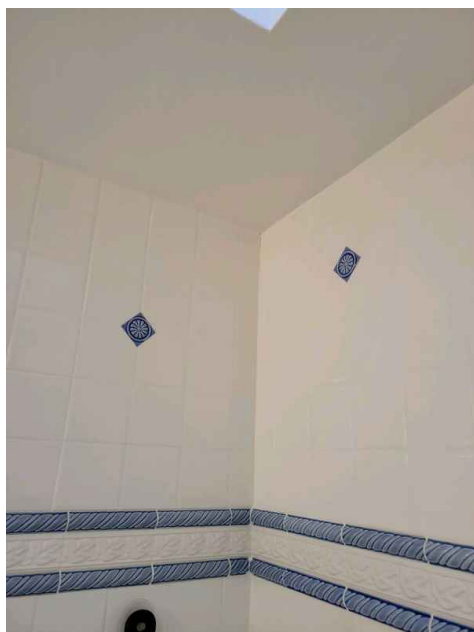
GROUT DAMAGED/MISSING

There appeared to be damaged and/or missing grout in the shower area. This could potentially lead to moisture intrusion. I recommend having a qualified contractor properly seal these areas.

Contact a qualified general contractor.

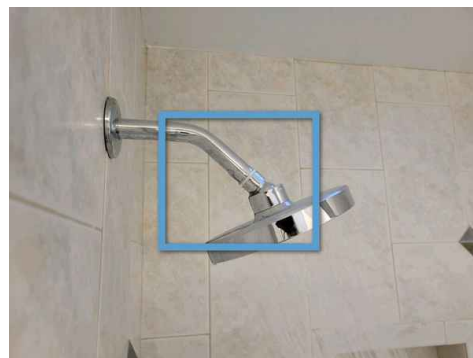
2nd Floor Bathroom

8.5.3 Shower/Bathtub
**SHOWER HEAD
MINOR LEAKING**

The shower head appeared to be leaking. This leak appears to be minor but may get worse in time. I recommend a qualified plumber or handyman to repair/replace to prevent any potential moisture damage.

Contact a qualified plumbing contractor.

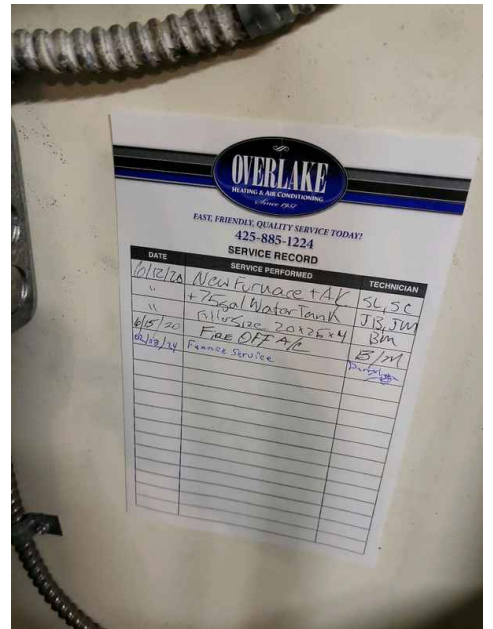
9.1.1 Equipment
FURNACE - RECENT SERVICING

Service sticker on the furnace indicated recent servicing. I recommend obtaining a copy of the receipt for your records, as well as having a point of contact for a future maintenance and operation questions. The standard life expectancy is 15 to 18 years with proper maintenance.

Contact a qualified HVAC professional.

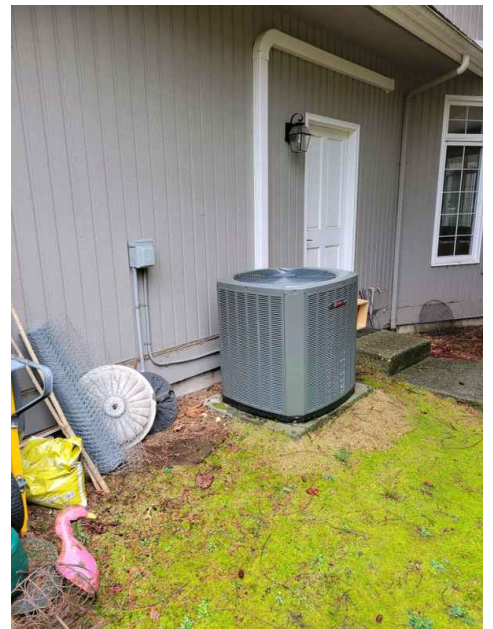
HEAT PUMP - RECOMMEND SERVICING

Home has a heat pump heating/cooling system installed. These systems provide heat and cool air to the area of home that has the evaporator coil mounted. Following manufacturer's recommendations for service is recommended to ensure efficiency and air quality. Inquire with seller on most recent service of the system. I recommend the unit be properly serviced per manufacturer's recommendations if the unit has not been serviced in recent seasons.

Contact a qualified HVAC professional.

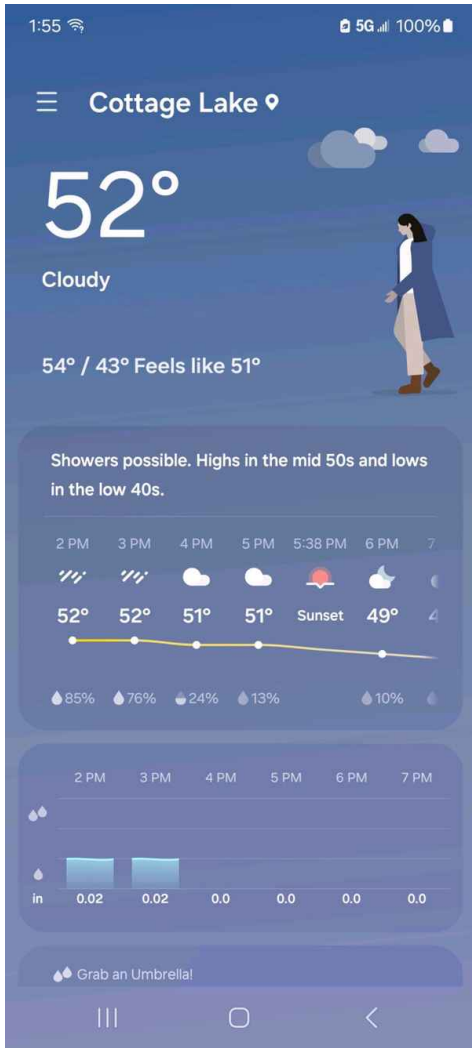
**A/C NOT TESTED -
LOW TEMPERATURE**

The A/C was not tested for proper operation because the outside air temperature was 65 degrees or less. Running the A/C in low temperatures can potentially damage the system. I recommend inquiring with seller as to the operation and service history of the A/C unit.

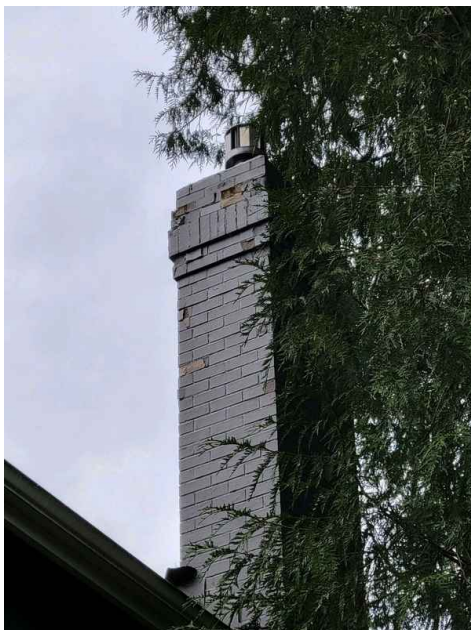
Right Side

SPALLING

Spalling noted on the bricks at the chimney. This occurs when moisture in the bricks freezes and the thaws. I recommend a qualified chimney specialist to repair/replace as necessary.

Inquire With Seller/Deferred Maintenance

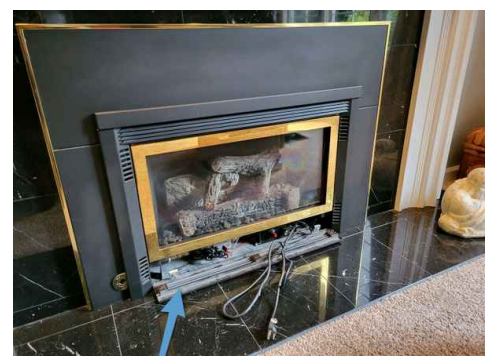
Primary Bedroom

FIREPLACE OFF

Gas fireplace was in the OFF position at the time of inspection therefore the fireplace was not tested. Inquire with seller regarding operability and service history. Additionally I recommend reviewing for operability during walk through.

Inquire With Seller/Deferred Maintenance

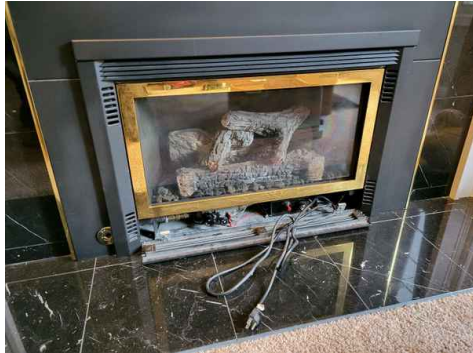
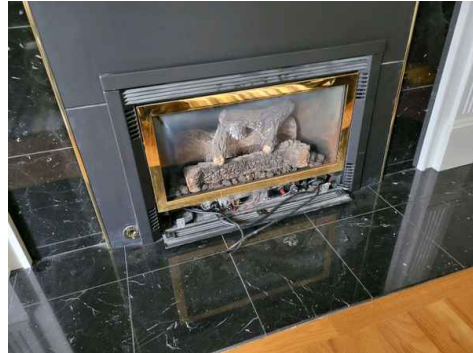
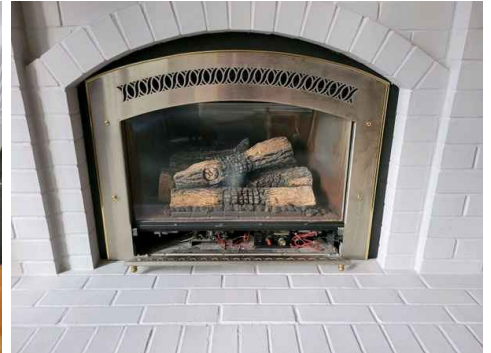
Inquire with seller on history of servicing of the gas fireplace. We recommend regular service as per manufacturers specifications. Unable to determine when most recent service was performed.

Contact the seller for more info

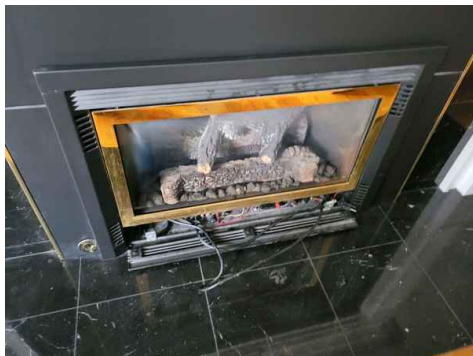
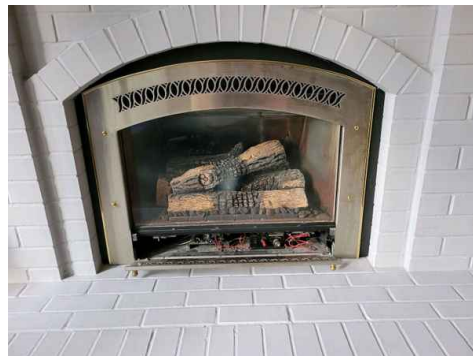
The pilot light appeared to be off at the time of inspection. It is unknown to the inspector if the fireplace is operable. I recommend inquiring with the seller about history and maintenance of the gas fireplace. If no servicing in the past 12 months I recommend a qualified HVAC specialist to evaluate and perform any necessary maintenance.

Contact a qualified HVAC professional.

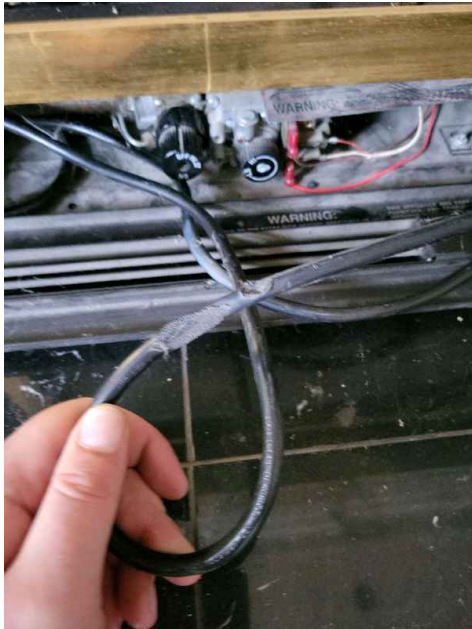
Living Room

A damaged or melted electrical cord was noted in the fire place. This can lead to shock and fire hazards. I recommend a qualified fireplace contractor evaluate for repair.

Contact a qualified fireplace contractor.

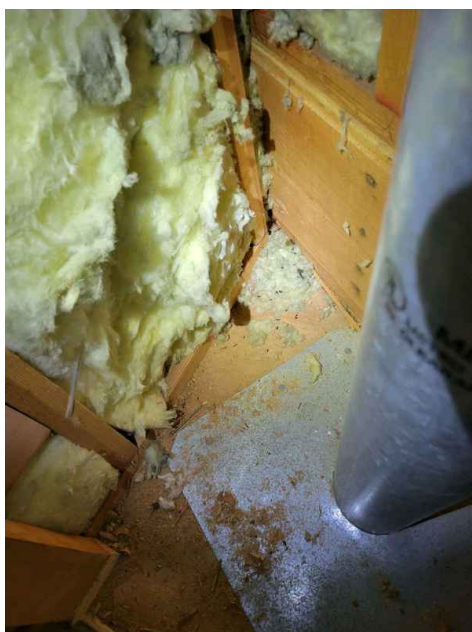
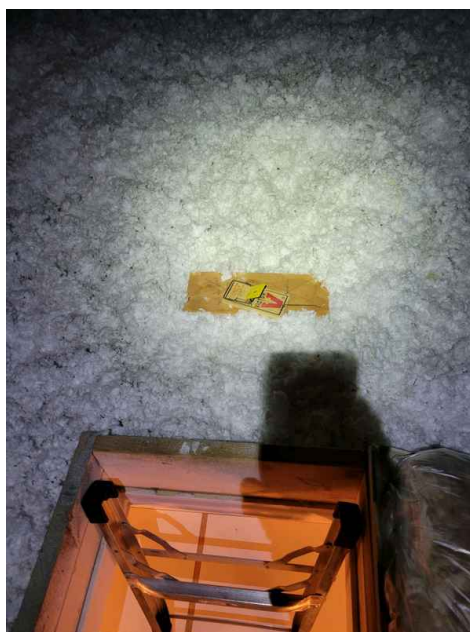
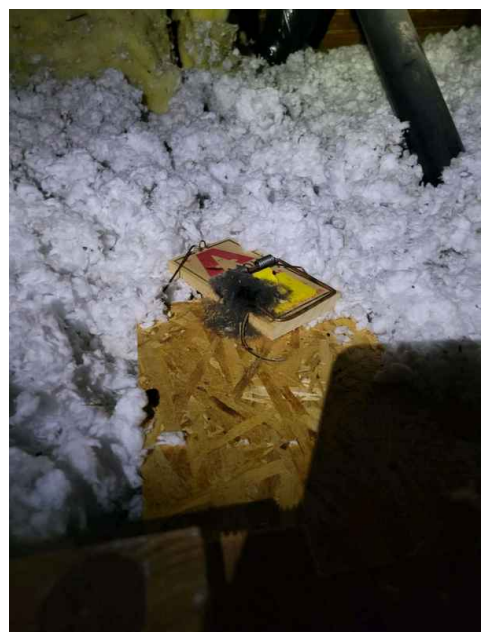
Rodent activity noted in the attic area. I recommend inquiring with the sellers on the history of rodent activity/infestation. I also recommend contacting a qualified Pest Control Operator to evaluate and remedy the situation which will include removing all rodents, rodent droppings, and damaged materials followed by taking the proper steps to ensure no future infestation will occur. Due to the common nature of rodent accessing different areas of the home, I recommend these steps also be taken in any other areas where pest activity/infestation has occurred. Also recommend having a qualified insulation contractor install new insulation in any areas where insulation was damaged/removed.

Contact a qualified pest control specialist.

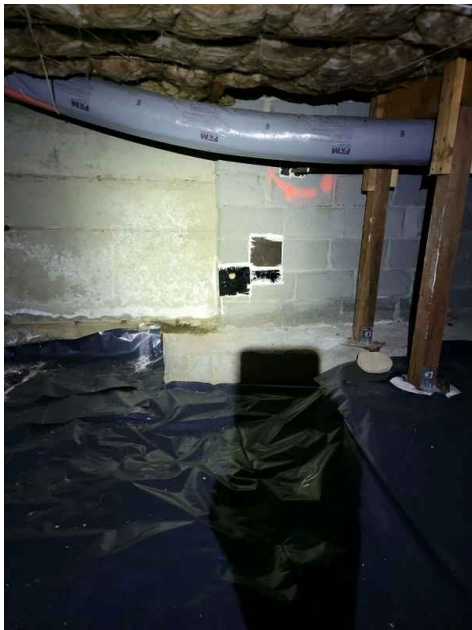
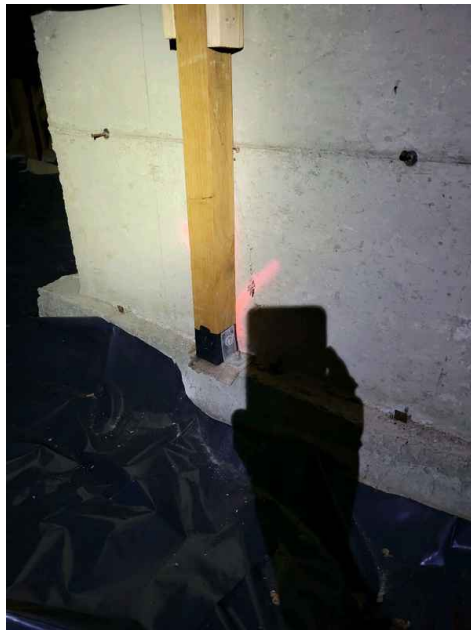
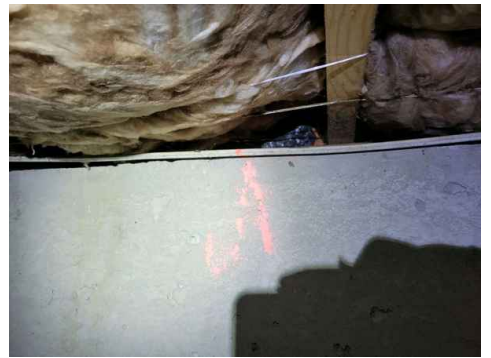
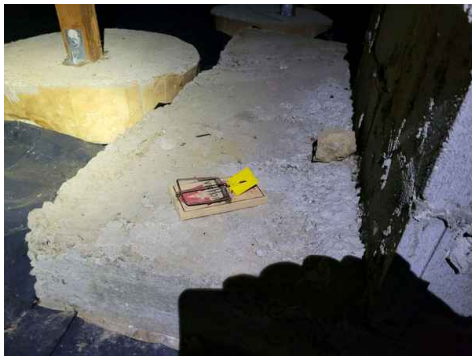
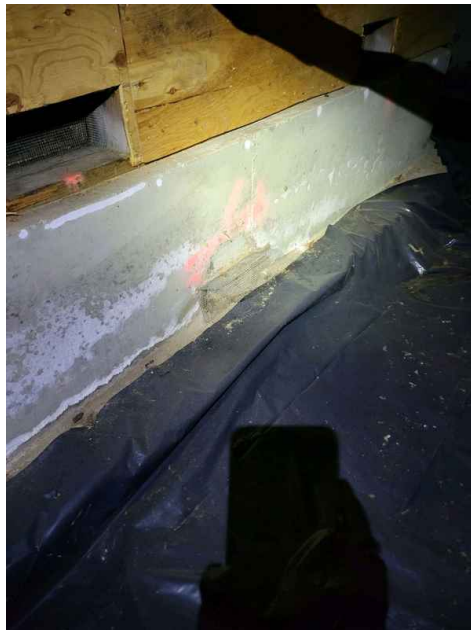
Signs of professional pest control observed in the crawlspace. I recommend inquiring with seller regarding known history of pest activity within the crawlspace and obtaining contractor information including receipts for the pest company that performed the work. Additionally, I recommend evaluation by a qualified pest control company to ensure the problem has been corrected.

Contact a qualified pest control specialist.

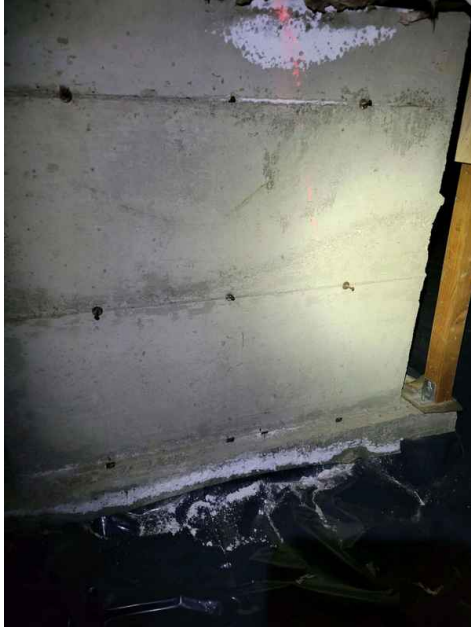
Front Center

White efflorescence (powder substance) and staining on concrete foundation walls indicates moisture is in contact with the masonry. This does not necessarily indicate that intrusion will occur. I recommend checking the gutters and the downspout drain lines for proper operation. Efflorescence is found on many homes without water intrusion occurring inside the home. But, it should alert you to the possibility that future steps may be needed.

Contact a qualified professional.

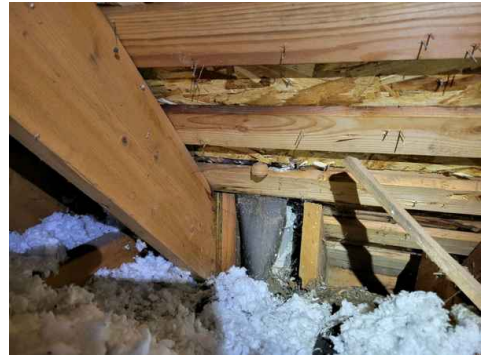
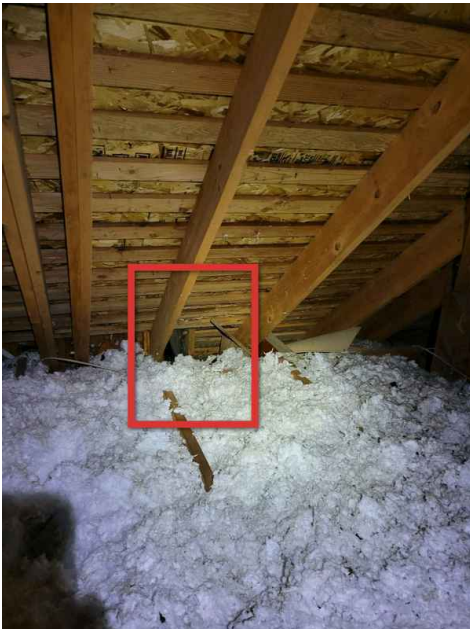
Front Lower attic

MOISTURE STAINS IN ATTIC ELEVATED MOISTURE

Moisture stains in attic. Area tested above normal moisture levels at time of inspection. I recommend a qualified roofer to evaluate the roofing system for any further repairs/replacement.

Elevated moisture reading

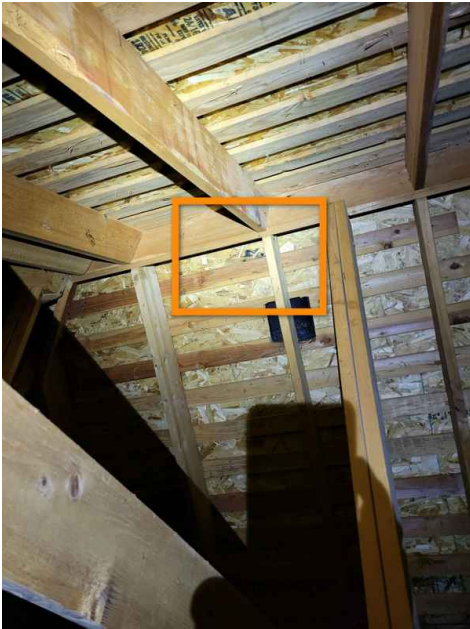
Lower attic

STAINING UNKNOWN MOISTURE

Safety Concern/Recommend Repair

Staining noted at the attic sheathing, due to its location the inspector was not able to verify if moisture was present. I recommend a qualified roofing contractor evaluate for any necessary repairs.

Contact a qualified roofing professional.

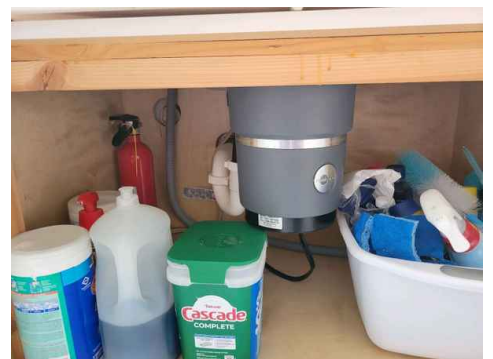
Typically, garbage disposals are not installed when there is a septic system on the property. I recommend inquiring with a qualified septic system professional concerning the use of a garbage disposal unit. Minimal usage of this appliance may be best. Items from the garbage disposal, powder soap from dishwasher and laundry units, cat litter and other foreign material can be harmful to septic systems.

Contact a qualified plumbing contractor.

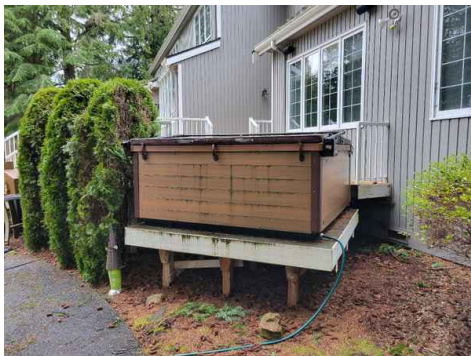
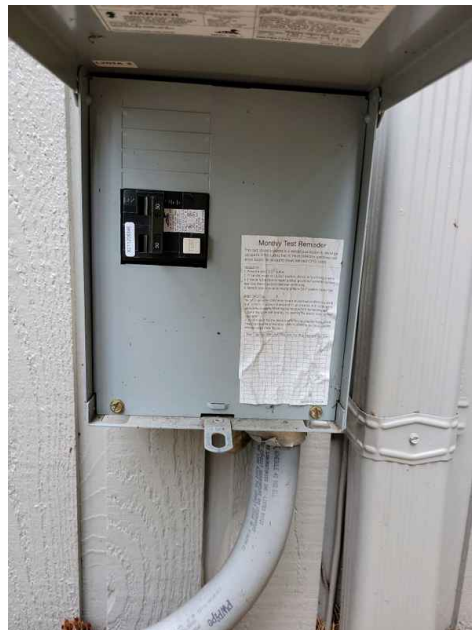
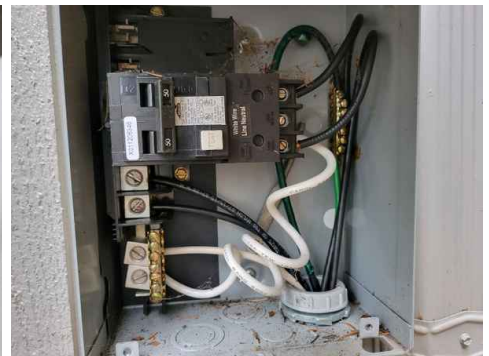
HOT TUB

Hot tubs and spas are not inspected during a standard home inspection. Hot tubs require a disconnect switch be located within visible, easy reach from the tub but far enough away from the edge of the hot tub to ensure the person reaching the switch is not in the hot tub at the time. Also, a GFCI circuit breaker installed at the electrical panel is required. I recommend a qualified electrical contractor evaluate the hot tub for safety features and repair/replace as needed.
